# Baton Rouge Refinery Facility (BRRF)

## CAA §112(r) CEI Photo Log

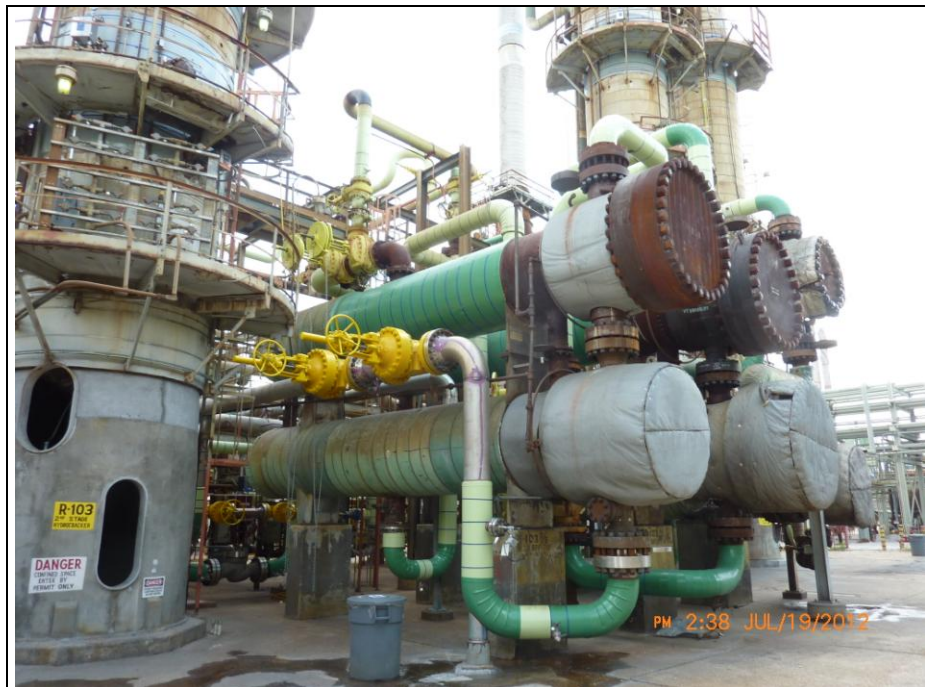
**PHOTO #:** 1

**COMMENTS:** HCLA Reactor R-102 Effluent/Fractionation Feed Heat Exchangers E-103 A/B/C/D/E inspected during walkthrough to confirm process safety information is current and accurate.

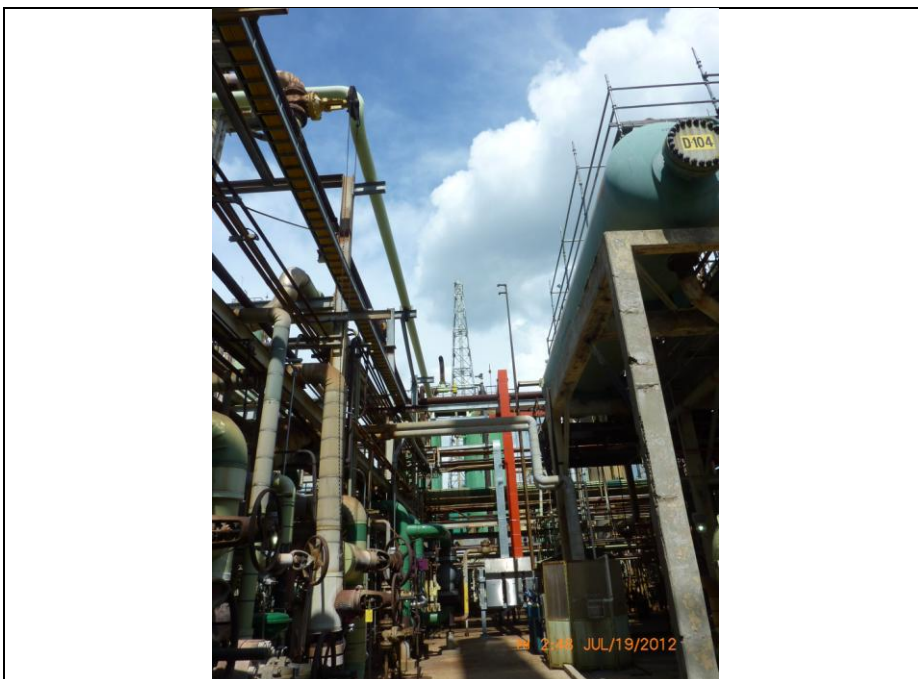
**PHOTO #:** 2

**COMMENTS:** HCLA Condensate Blowdown Drum D-115 vent to atmosphere is shown in center of photograph supported by derrick supports.

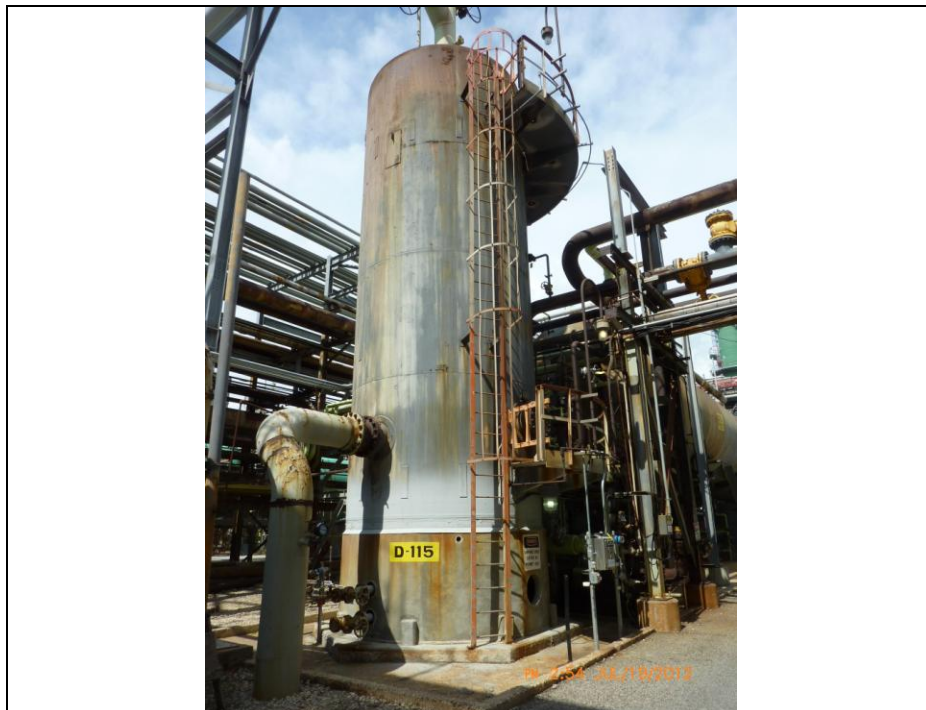
**PHOTO #:** 3

**COMMENTS:** HCLA Condensate Blowdown Drum D-115 condensate blowdown tank inspected during walkthrough to confirm process safety information is current and accurate.

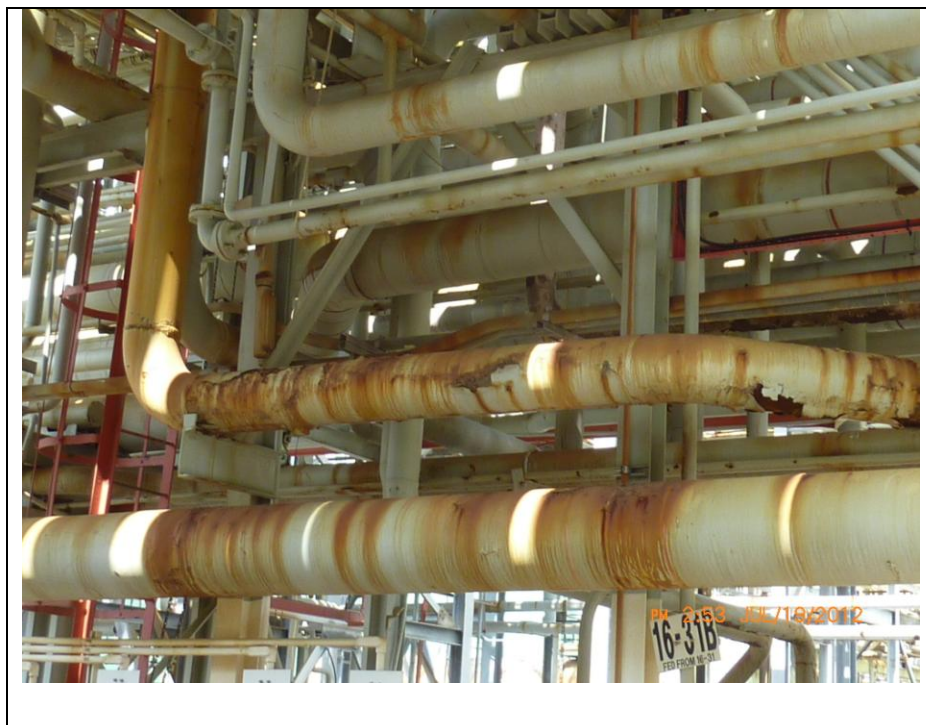
**PHOTO #:** 4

**COMMENTS:** Piping located in HCLA unit block shows signs of significant corrosion and scaling.

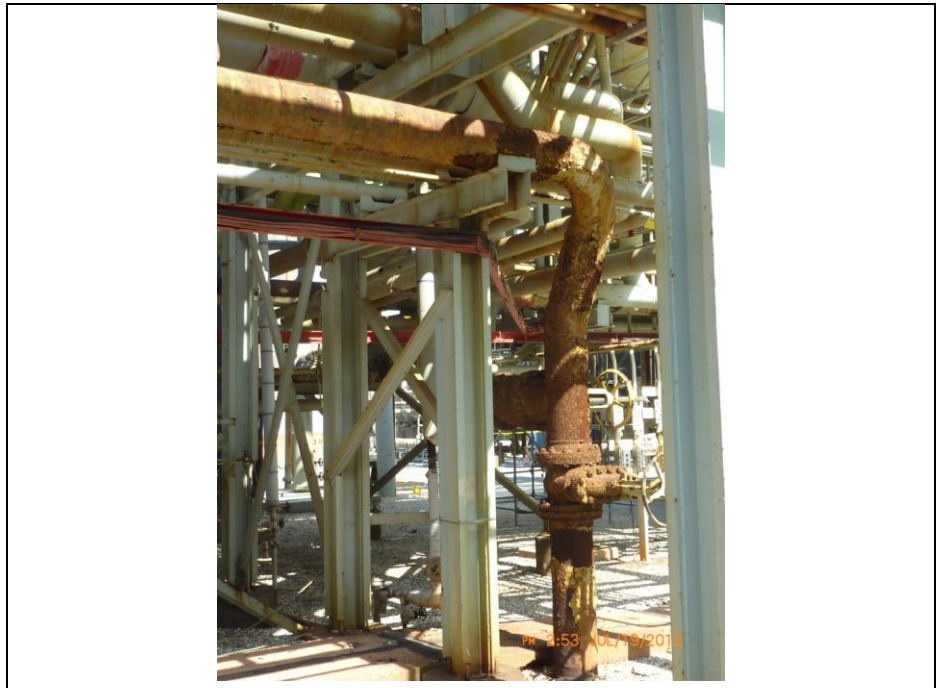
**PHOTO #:** 5

**COMMENTS:** Piping and valve located in HCLA unit block shows signs of significant corrosion and scaling. Piping enters the ground at the base of the support structure and travels underground.

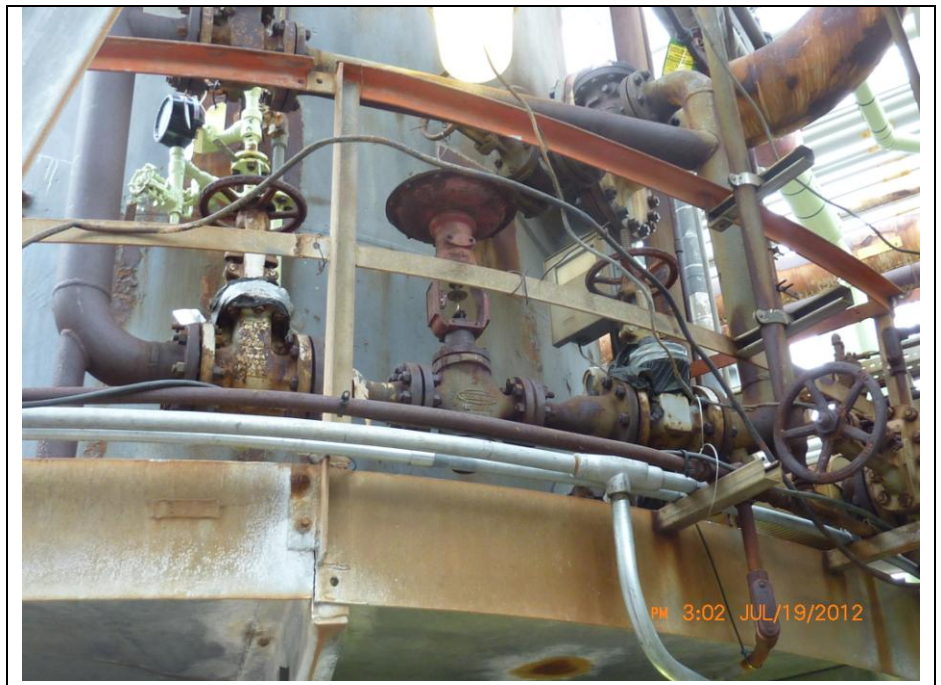
**PHOTO #:** 6

**COMMENTS:** Piping and valves located on D-115 Condensate Blowdown Tank system. Hand valves on either side of the automatic valves were wrapped in garbage bags and secured with duct tape. The unit operator stated the valves were wrapped to protect them from the corrosive vapor emitted from the PCLA wet gas scrubber exhaust when the scrubber was started up. The walls of D-115 showed signs of corrosion and pitting behind the piping elbow on the left side of the photograph.

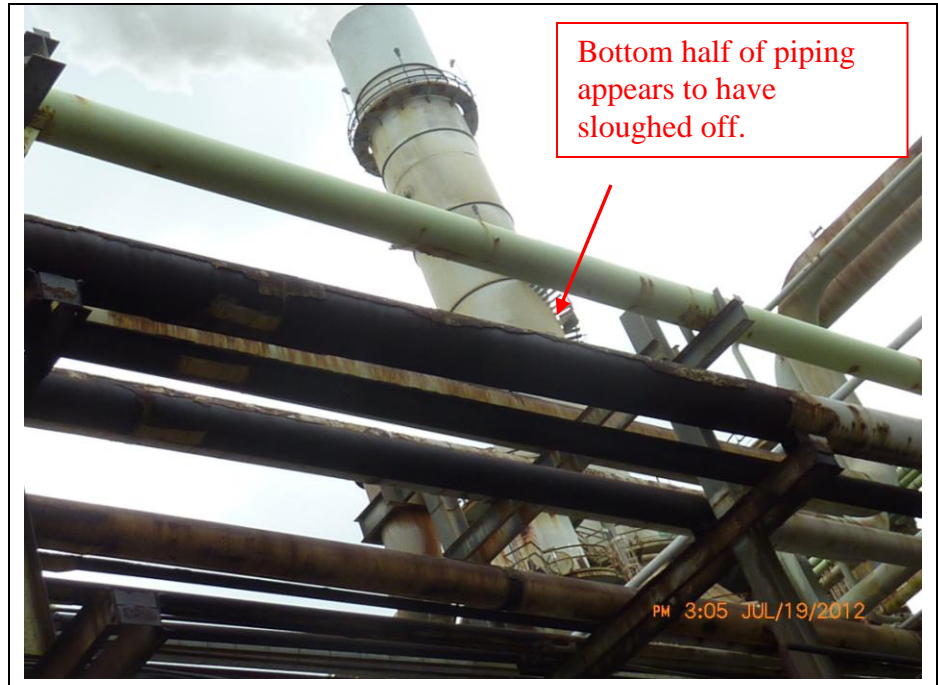
**PHOTO #:** 7

**COMMENTS:** Overhead piping located in HCLA unit block near D-115 shows signs of significant corrosion and scaling. A significant amount of metal has sloughed off from the bottom of the pipe that appears to be second from the top of the photograph. The unit operator was unable to determine the process fluid in the pipe but believed it to be high pressure hydrogen.

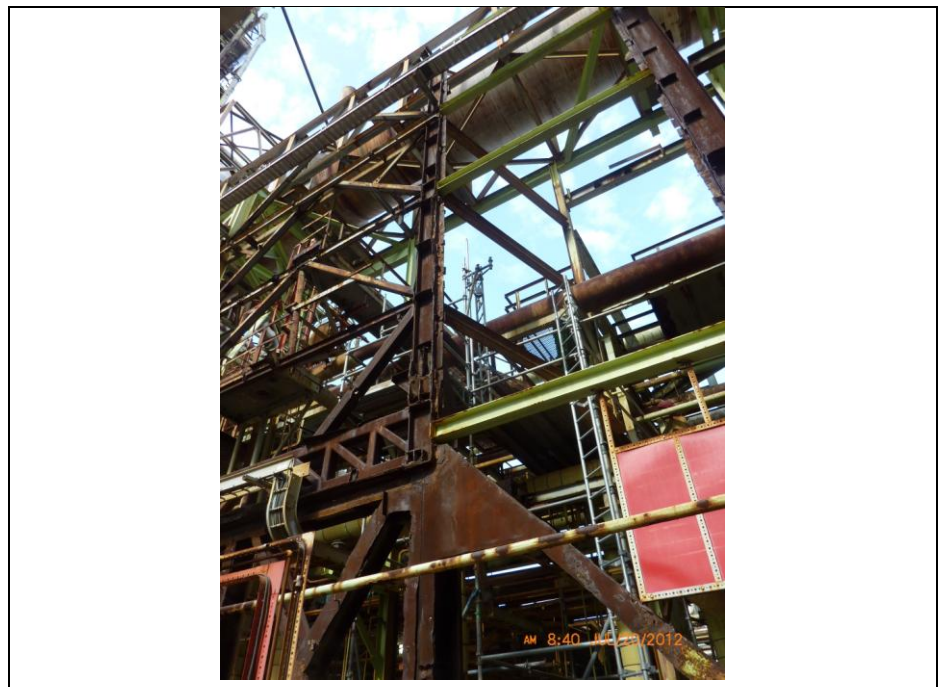
**PHOTO #:** 8

**COMMENTS:** Steel beams supporting the PCLA wet gas scrubber feed pipe shows signs of significant corrosion.

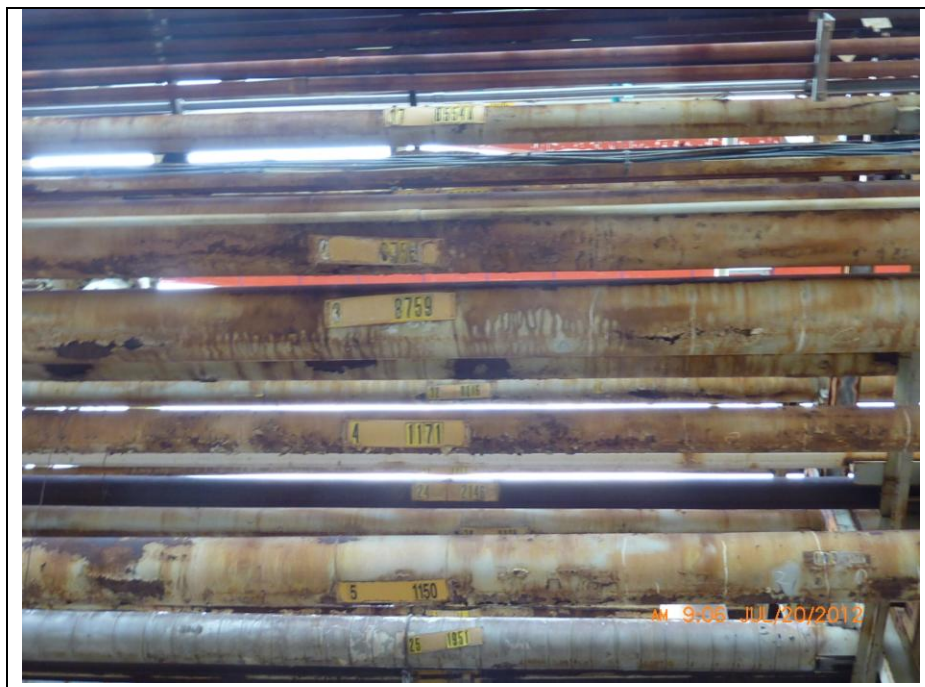
**PHOTO #:** 9

**COMMENTS:** Overhead piping located in HCLA unit block shows significant corrosion on a majority of the pipes running through the area.

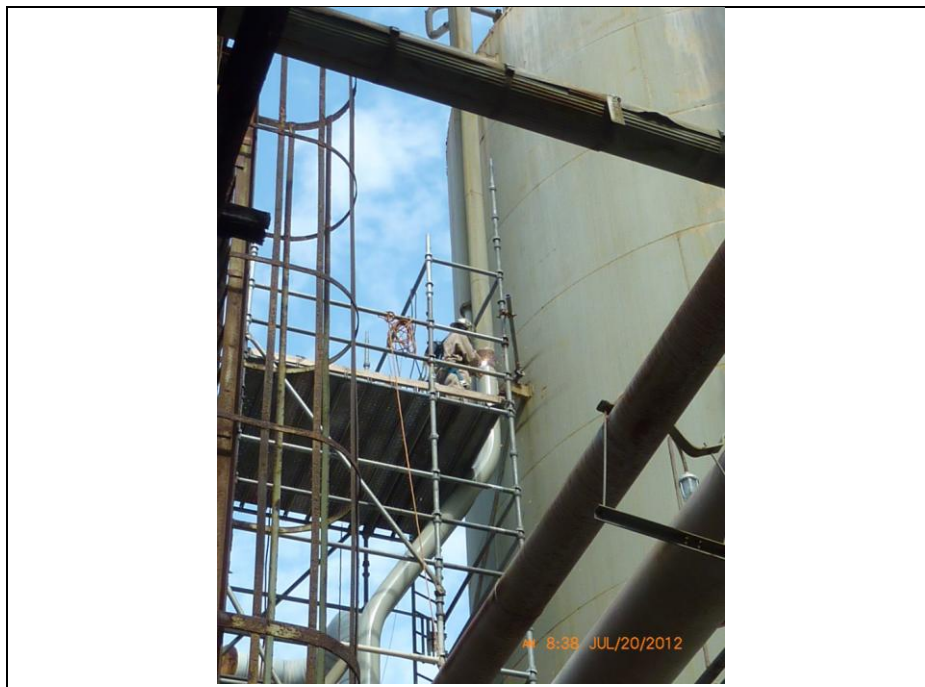
**PHOTO #:** 10

**COMMENTS:** Hot work in PCLA are under Permit #571370.
