## Natural Infrastructure Restoration to Enhance Climate Resilience in Puerto Rico

**“Assessing Jobos Bay and Aguirre Park (Puerto Rico) mangrove wetlands extension, shoreline condition and rehabilitation/restoration feasibility after Hurricanes Maria and Irma impacts (2017)”**

**DRNA/ JBNERR**  
In collaboration with  
**The Ocean Foundation**  
**Merello Marine Consulting**

**September 16, 2020**

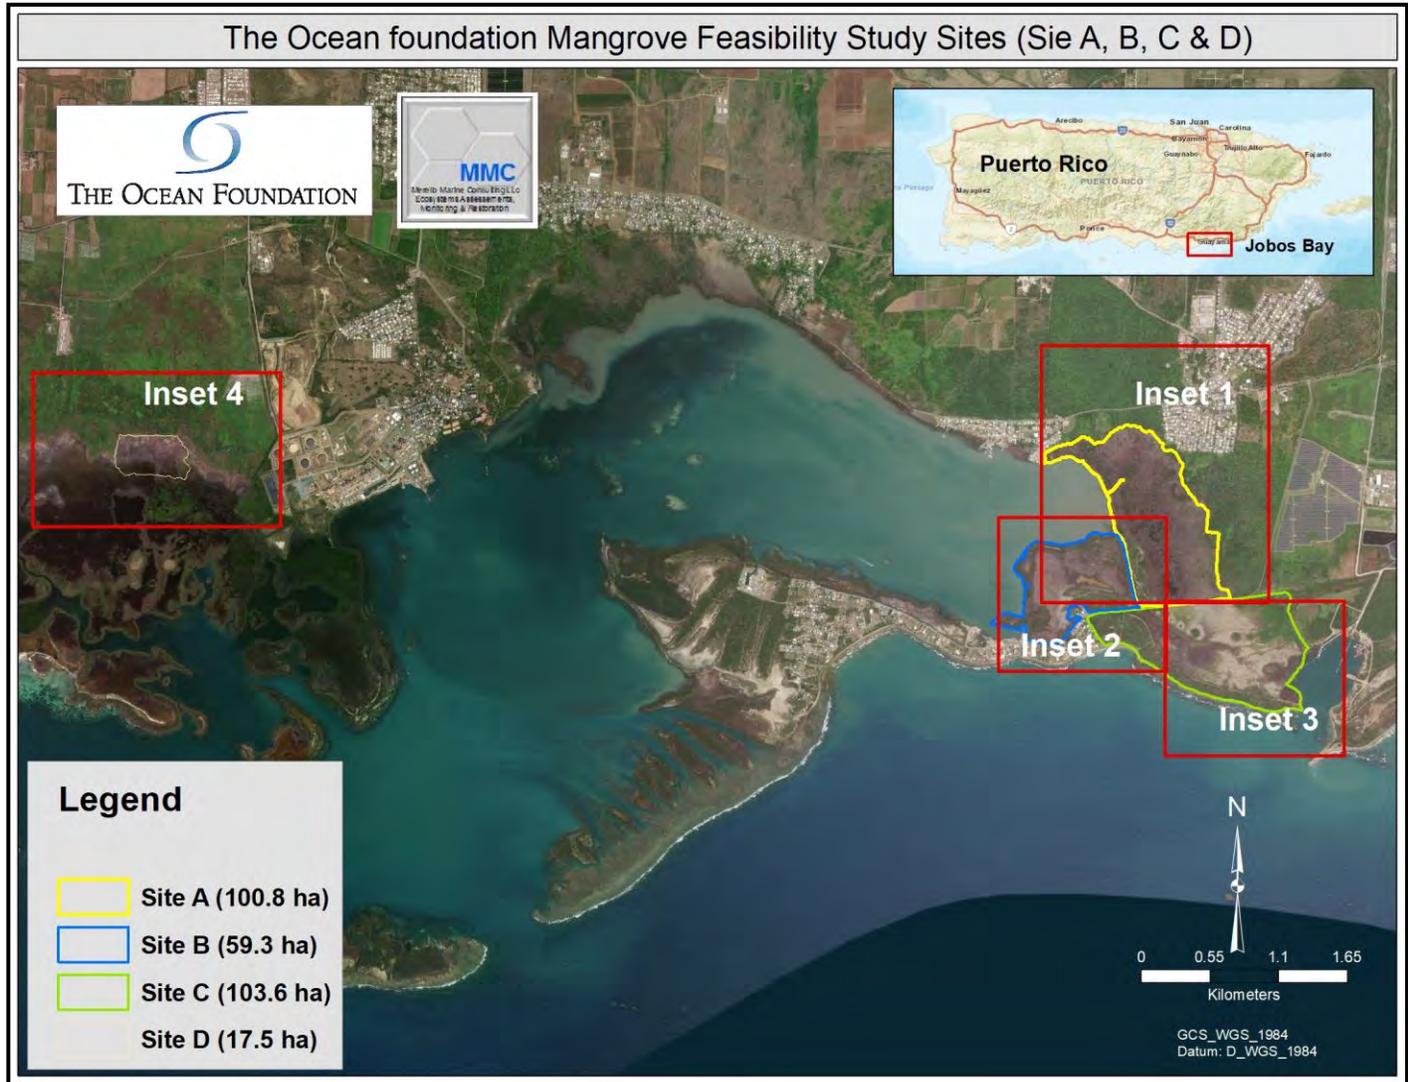
**Figure 2. Aerial image of Jobos Bay, Puerto Rico showing the mangrove study sites (Site A, B, C, and D) selected by JBNERR/DRNA, the Ocean Foundation and Merello Marine Consulting for the Mangrove Feasibility Study for the restoration activities.**

The selection of candidate restoration sites utilized a three-tier process. Initial site selection conducted in tier 1 incorporated a geo-spatial analysis based on NOAA's rapid assessment of Hurricane's Irma and Maria's impacts in Jobos Bay during 2017 (NOAA 2018). The NOAA assessment included a review of pre- and post-hurricane high resolution satellite and aerial imagery focused on identifying and locating key indicators of broad-scale disturbance. In order to identify potential hurricane damage in Jobos Bay, and Aguirre Park (state park located adjacent to Jobos Bay) at a higher resolution, the second tier of our evaluation relied on additional detailed interpretation of imagery by the non-profit organization The Ocean foundation. This assessment focused on a specific set of candidate sites in Jobos Bay and at the adjacent park Parque de Aguirre that were identified in a comparison of pre- and post-storm imagery. Where possible, we also used the same imagery to identify potential mangrove sites negatively impact by vessel landings due to storm surge (henceforth, vessel injury sites) including damage incurred to mangrove structure due to vessel initial damage and cleaning/removal activities. The polygons of suspected hurricane related damage produced by NOAA were compiled and inspected in ARC GIS and then compared in order to develop a final list of **4 candidate sites** for field inspection (**Figure 2**).

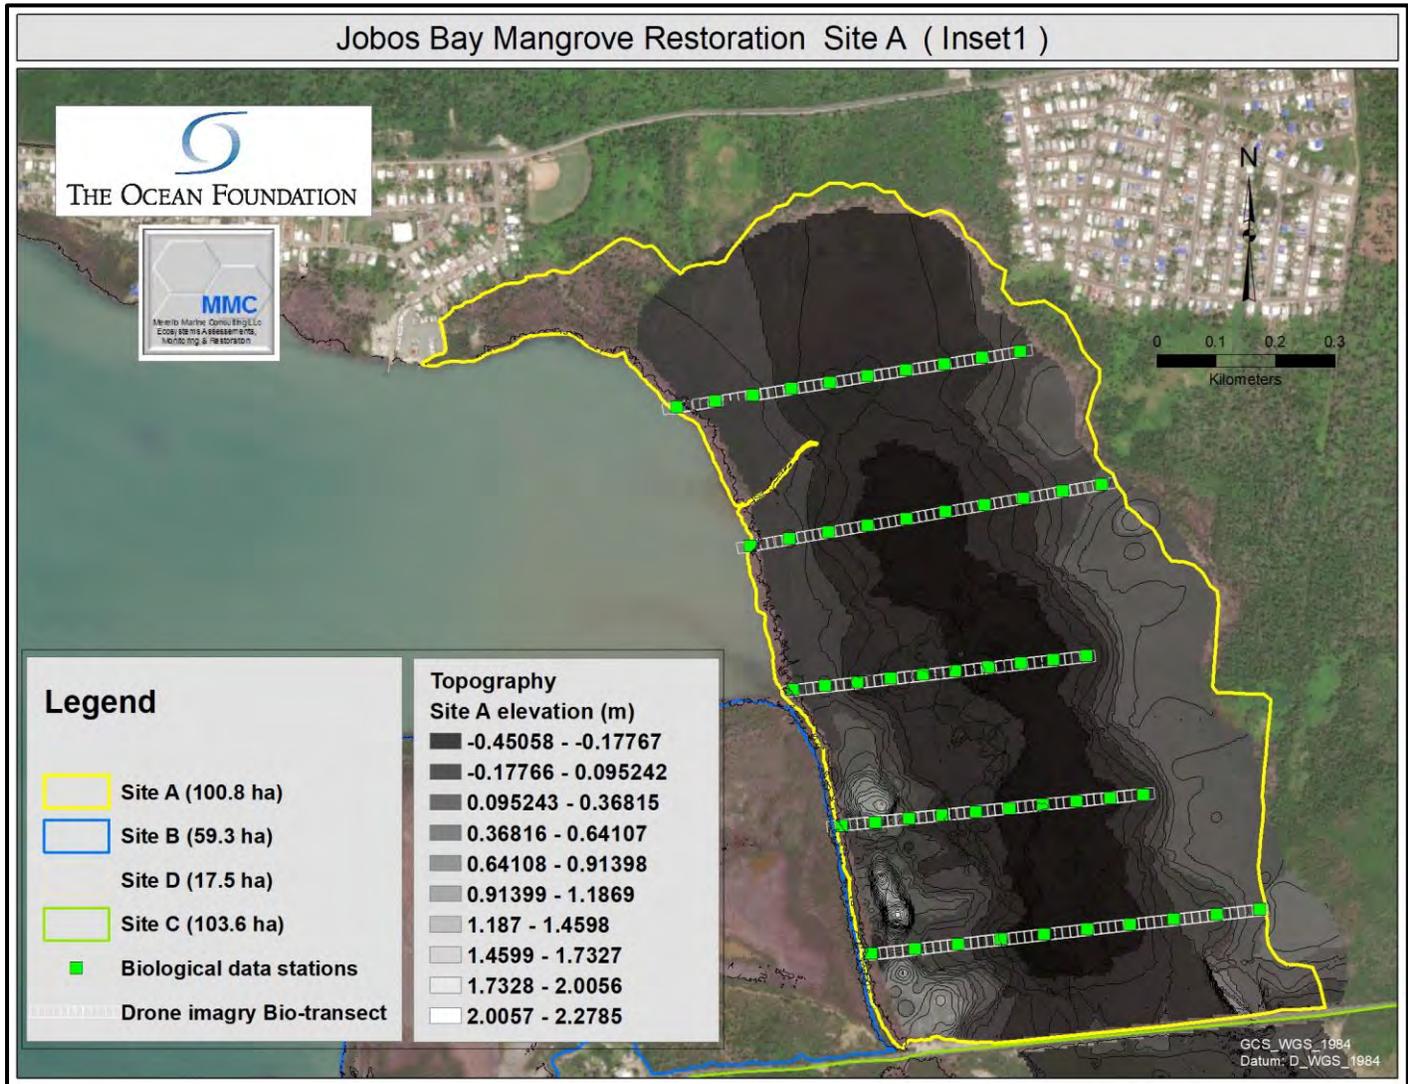
**Figure A. Aerial image of Site A showing the feasibility study area topography (Inset 1).**

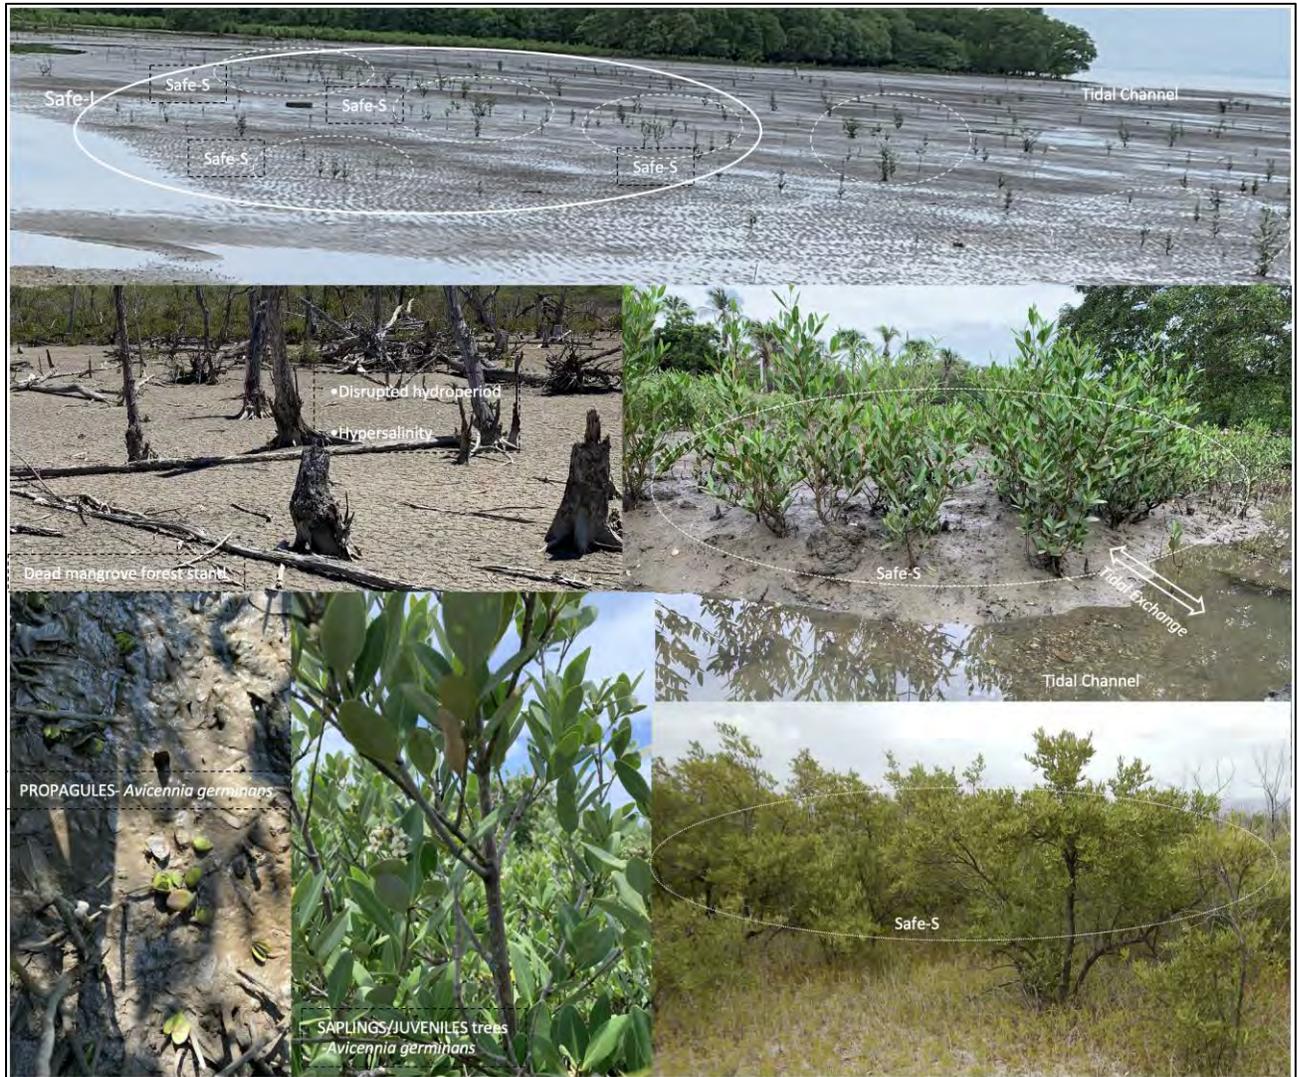
**Figure 2A. Sites with different mangrove seedlings/saplings/propagule density showing different stages of colonization.** Vegetation density represents different stages in the SAFE-SITE (Safe-S) and SAFE-ISLAND (Safe-I) conceptual framework. Safe-S includes the selection of sites where environmental conditions surrounding seeds/propagules/ saplings favor natural regeneration establishment and growth (Harper et al 1961; Urbanska 1997) and based on species ecophysiological adaptations. SAFE-S requires hydrological rehabilitation as a first step in restoring/rehabilitating negatively impacted/injured mangrove wetlands. See text for explanation.

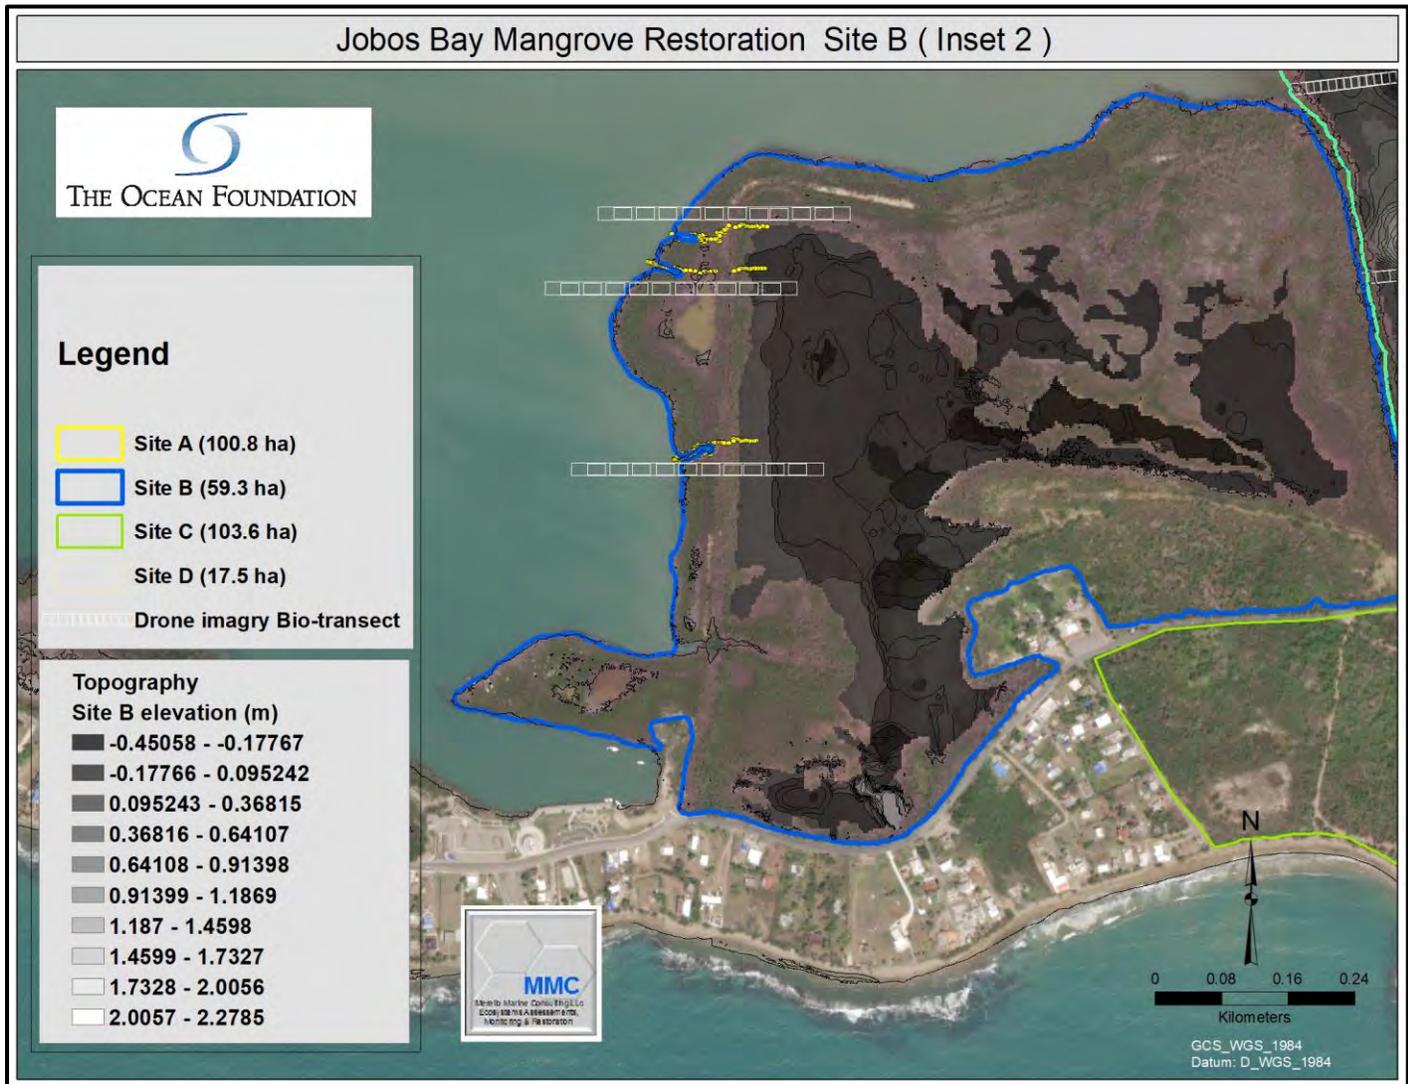
**Figure B. Aerial image of Site B showing the feasibility study area topography (Inset 2).**

**Site B:** Site B is a 59.3-hectare mangrove forest located in the municipality of Aguirre as well, and with the boundaries of the State Park Bosque de Aguirre; this area has impacts similar in extension as observed in site A (**Figure B**). The mangrove wetlands in this area are mainly composed of *A. germinans* but also include areas where *Rhizophora mangle* and *Laguncularia racemosa* are present. Similar to site A, this site is below sea level (-0.0 to -0.45m) and also surrounded by higher elevation in the range from 0.0 to 0.60m; the lack of tidal flow is apparent as well. Forest structural and forest canopy is also evident along with changes in the topography as indicated by higher water residence time in the central areas of the site (**Figure B** and appendix A, archive images and drone imagery). Both water flow and biological restorations are needed to return and accelerate mangrove wetland natural regeneration. One key management strategy is to extend three (3) previously excavated channels dredged during the removal of derelict **vessels**. Fully opening these 3 channels will improved tidal water circulation and increas water exchange between the interior areas and the bay; this reestablished flow can promote natural mangrove forest regeneration and recovery close to channel I and provide a source of propagules needed to expand colonization of other unvegetated areas.

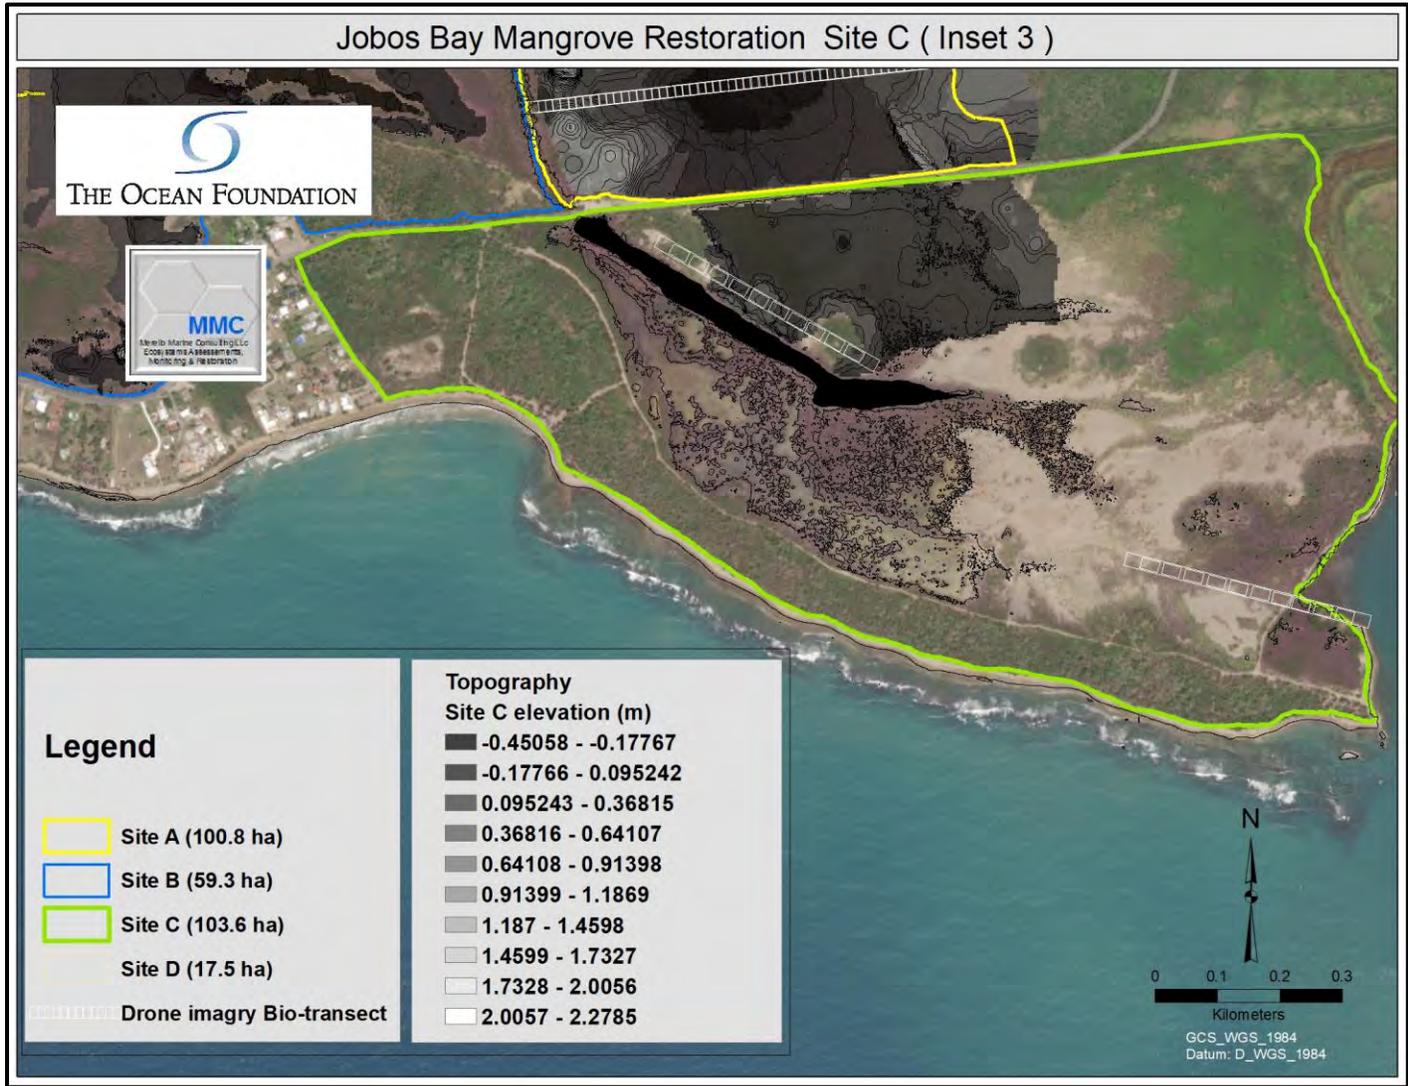
**Figure C. Aerial image of Site C showing the feasibility study area topography (Inset 3).**

dominated by the mangrove species *A. germinans* followed by *R. mangle* and *L. racemosa*. The mangrove forest was heavily damaged by Hurricanes Irma and Maria. Both mangrove soil and sediments along channels were partially redistributed due to the lack of vegetation root system resulting in alterations of the local natural drainage and hydrology (**Figure C**) as observed in Sites A and B.

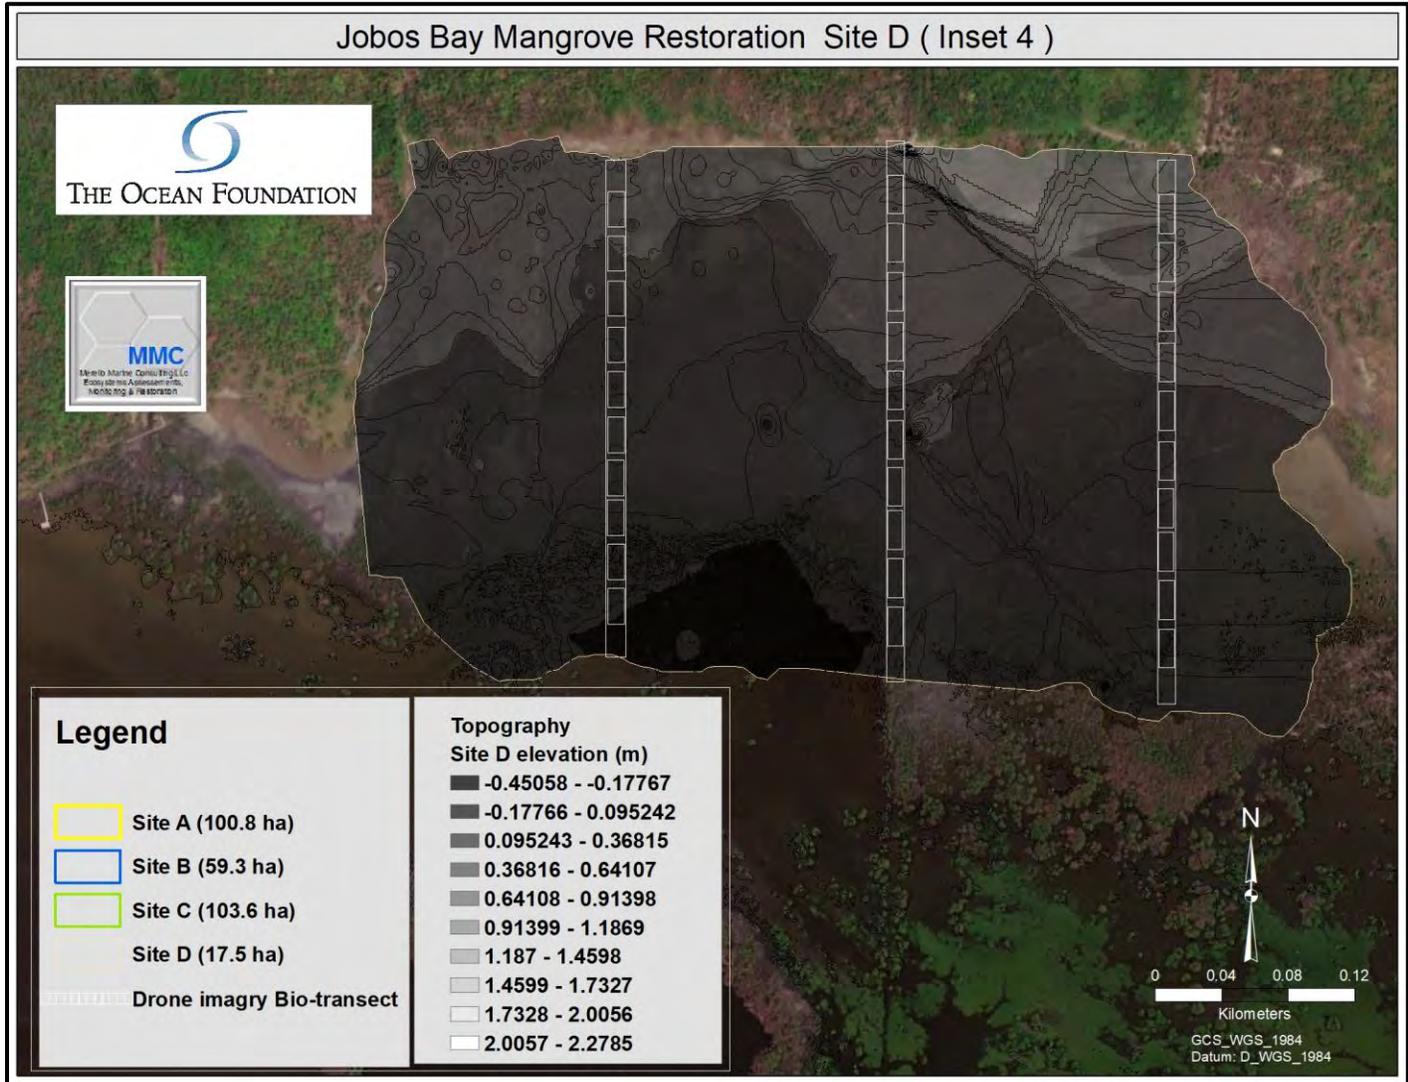
**Figure D. Aerial image of Site D showing the feasibility study area topography (Inset 4).**

damaged by Hurricanes Irma and Maria, knocking down a number of trees (**Figure D**, see appendix A for images). This site has a smooth gradual elevation (approx. 1.0 to -0.42m) from the shoreline (North) to the most seaward direction (South) making the inundation and hydroperiod potentially optimal for the natural recovery of the forest, although direct hydroperiod measurements are recommended.

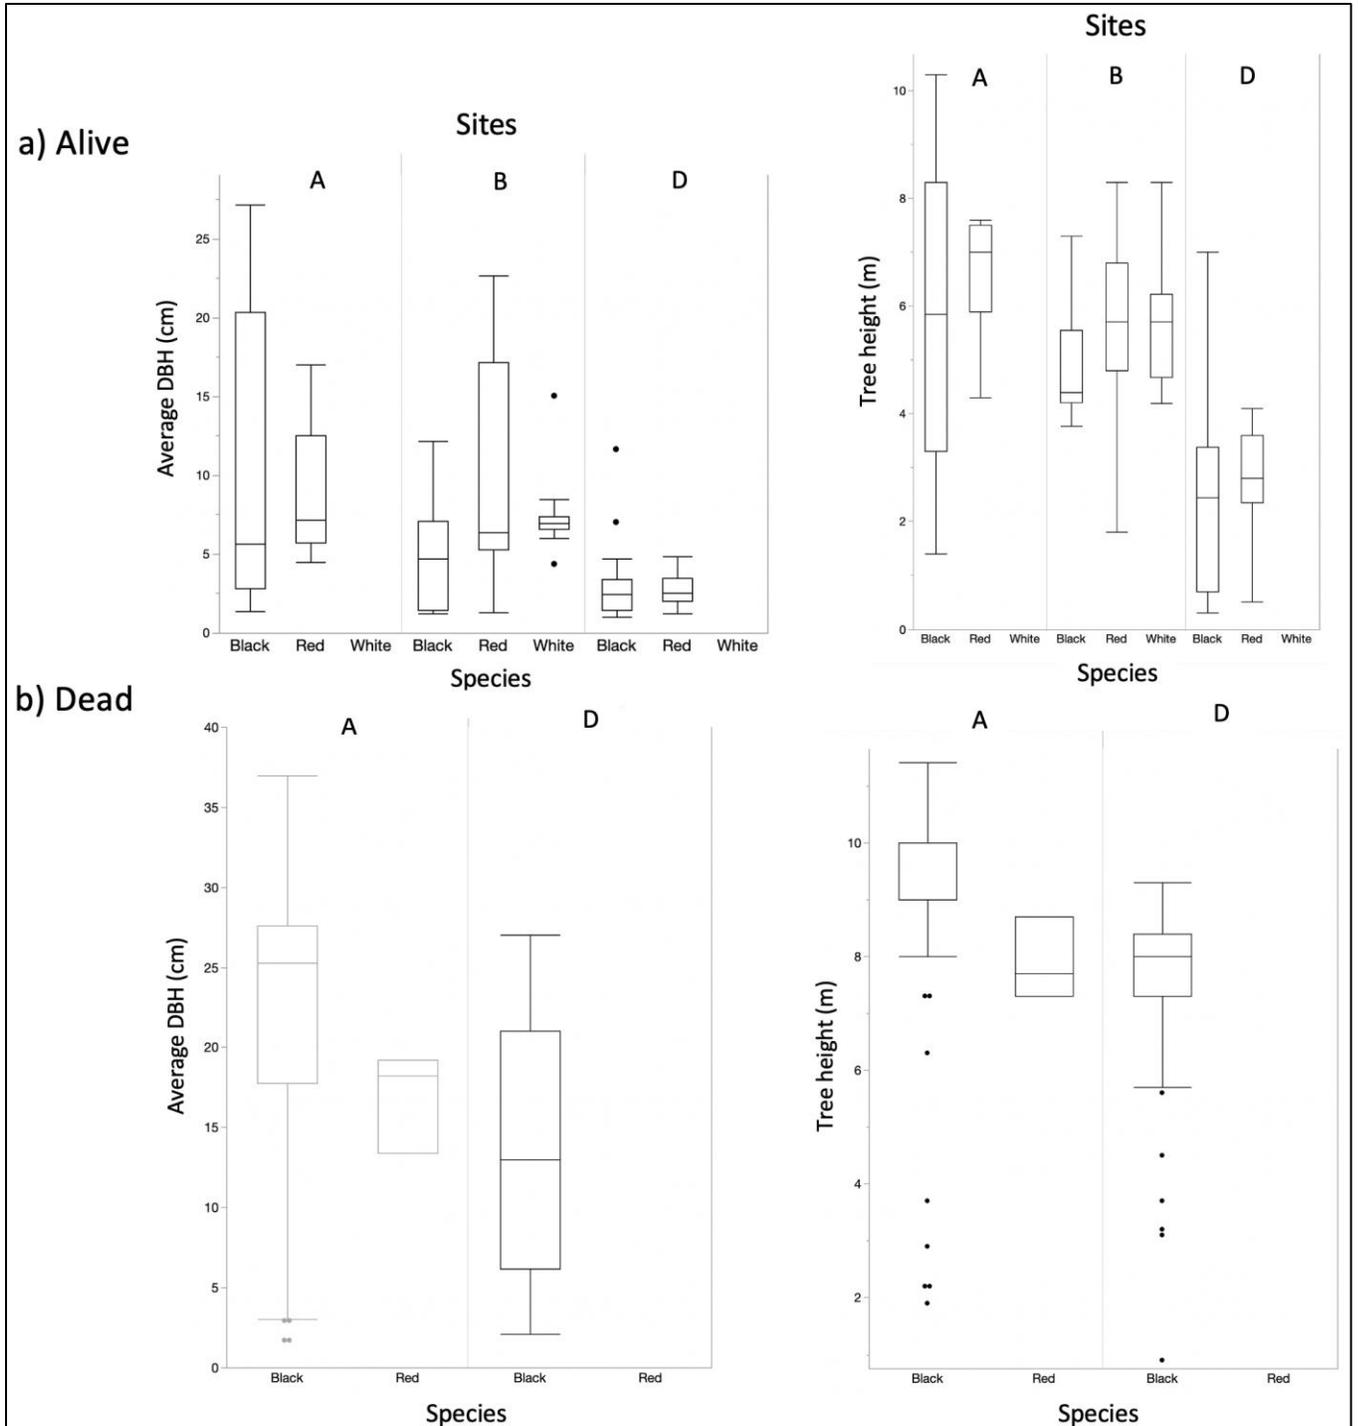
**Graph 1. Diameter at breast high (DBH) and tree height along transect per survey site. A) Alive trees. B. Dead trees.**

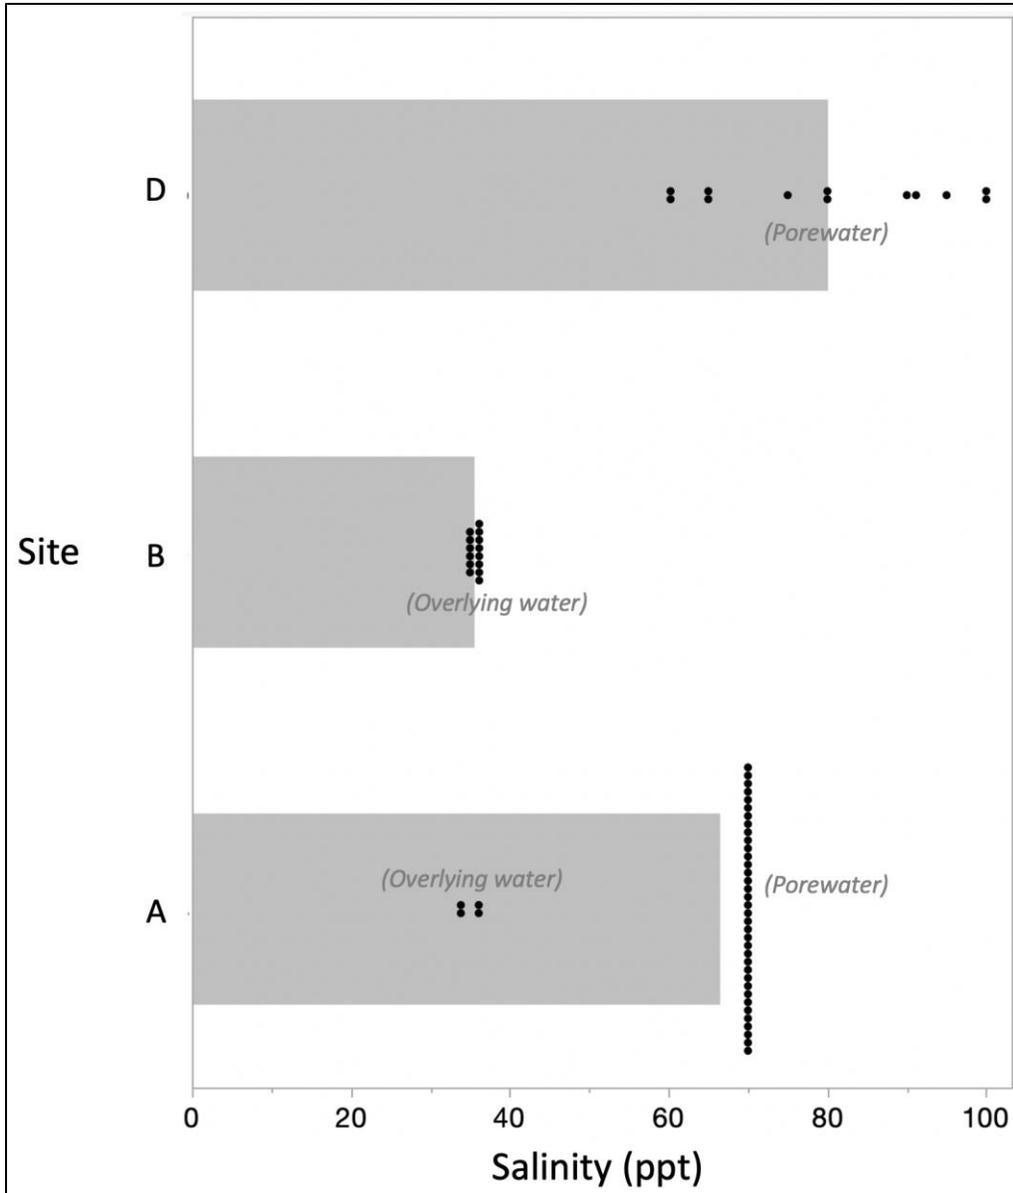
**Graph 2. Surface water salinity and soil porewater salinity** along transects in survey areas in the JBNEER. See Figure for site and transect locations. Surveys were performed on August 20, 2020.

in these already hydrological impacted areas was on average 70 ppt (**Graph 2; Sites A, B, D**). And although mangrove forests, as is the case of the black mangrove, can withstand high salinities (>50 ppt) on seasonal basis, persistent hypersalinity conditions trigger cumulatively extensive diebacks over several years (**Graph 2**) (Lopez-Portillo et al. 2005, Rivera-Monroy et al. 2006b, Mendez-Alonzo et al. 2008, Madrid et al. 2014, Medina et al. 2015).

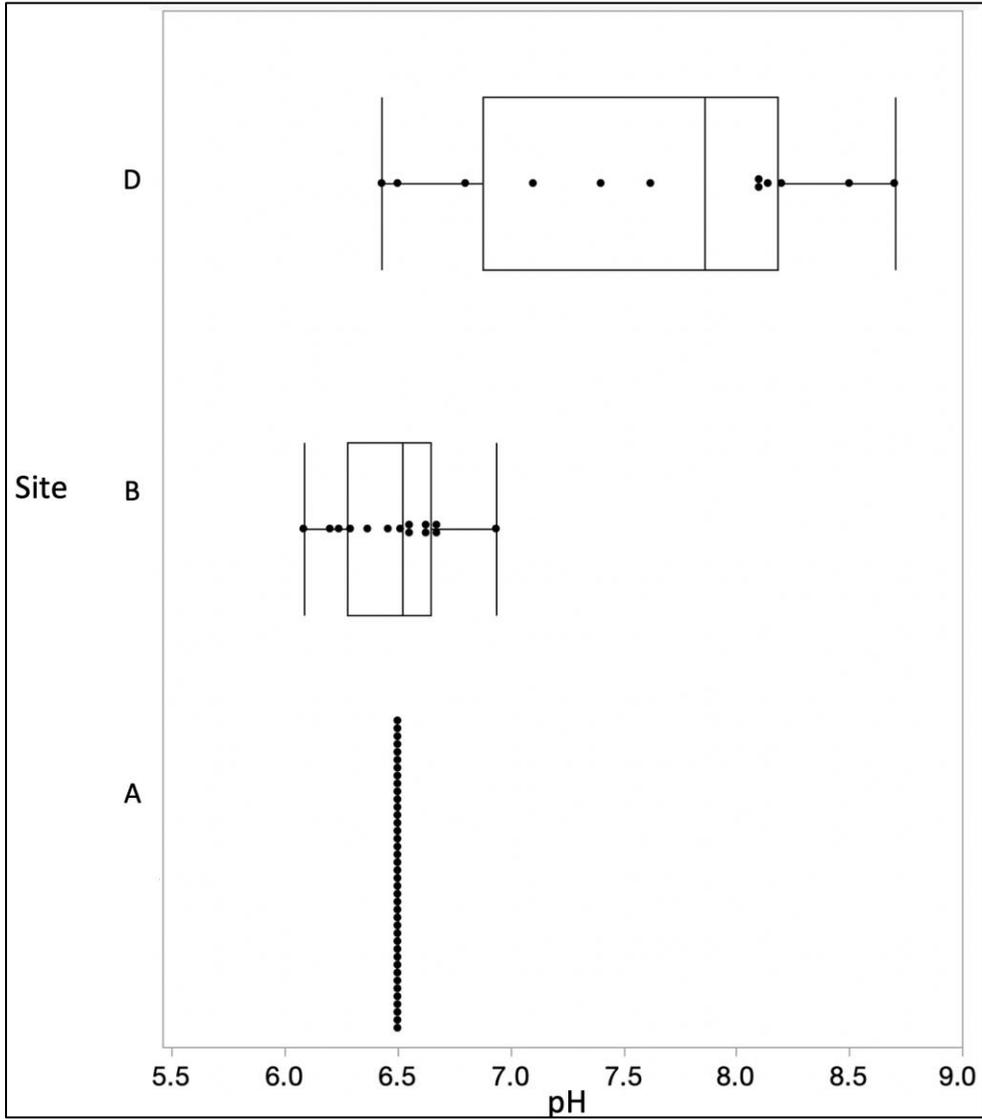
**Graph 3. pH values in soil porewater** along transects in survey areas in the JBNEER. See Figure for site and transect locations. Surveys were performed on August 20, 2020.

In addition to salinity, surface water pH measurements were measured across transects in all sites (**Graph 3**). Values ranged from 6.5 (site A) to 8.7 (site B) indicating the wide variability in soil origin/composition and biogeochemical processes controlling organic matter decomposition and nutrient availability; this occurs in locations previously dominated by mangroves. In particular, acidic conditions are prevalent in Sites A and B (**Graph 3**). These values suggest a higher accumulation of organic compounds probable as a result of long-term accumulation of organic matter and wood debris. This pattern is in contrast with site D where pH values are also close to basic marine water values (pH, 8.1), even when the site lacks tidal exchange. Further studies are needed to elucidate the seasonal net differences in soil and overlying water pH values, which fluctuate along with daily and seasonal hydroperiod.

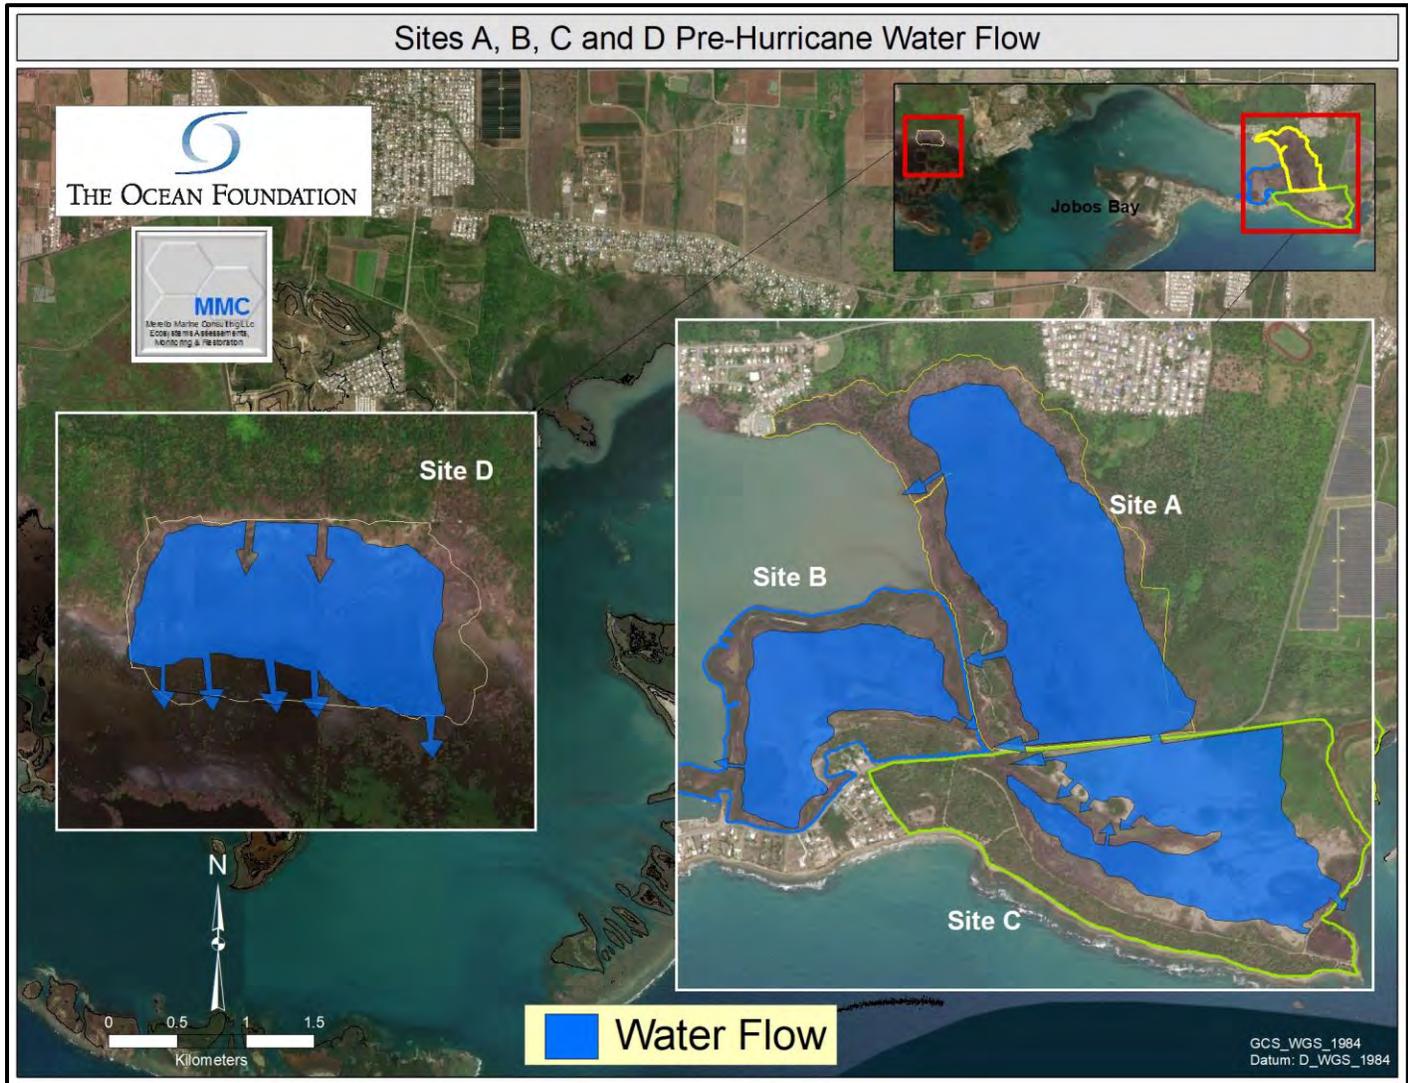
Figure 3. Pre-hurricane water flow at Sites A, B, C, and D.

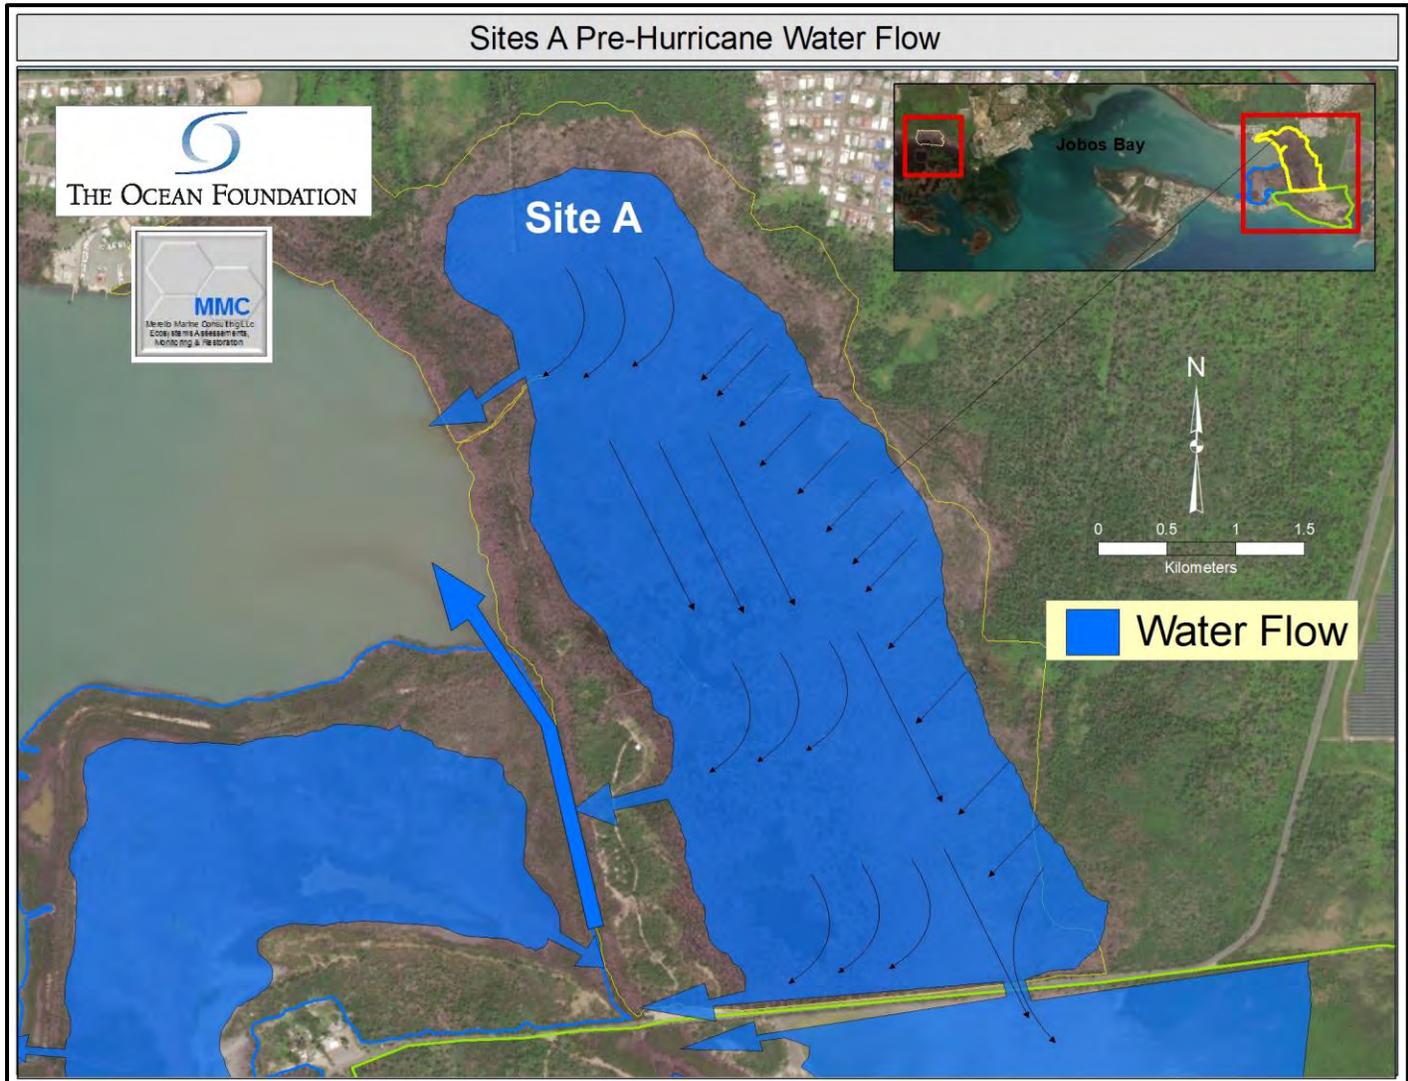
Figure 3A. Site A general water flow.

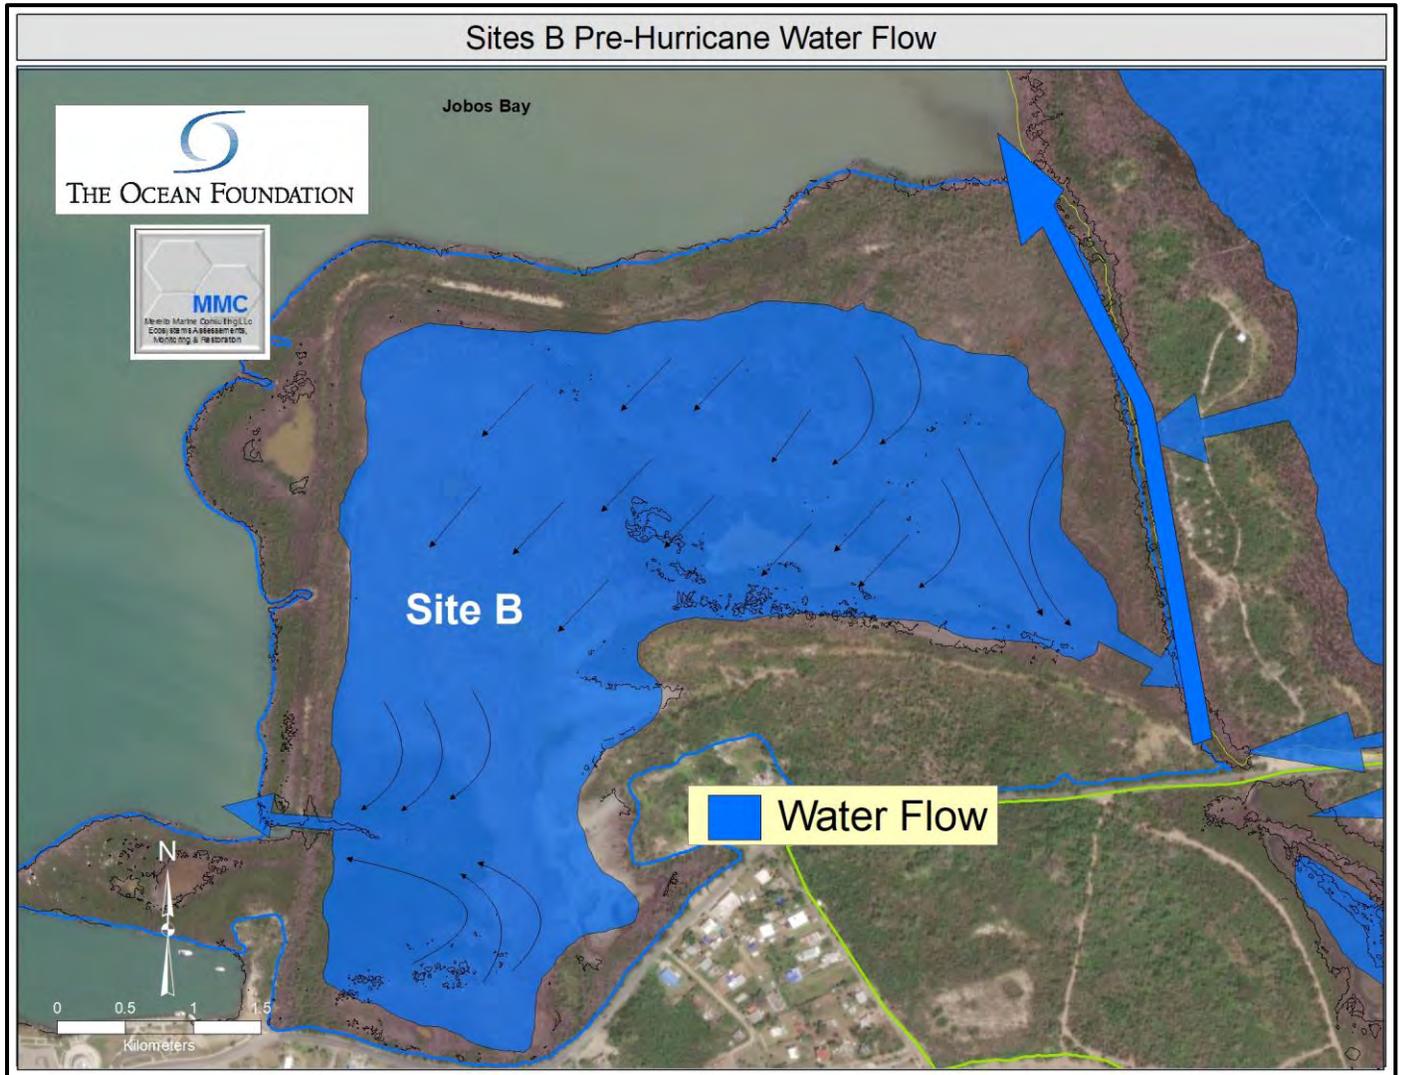
Figure 3B. Site B general water flow.

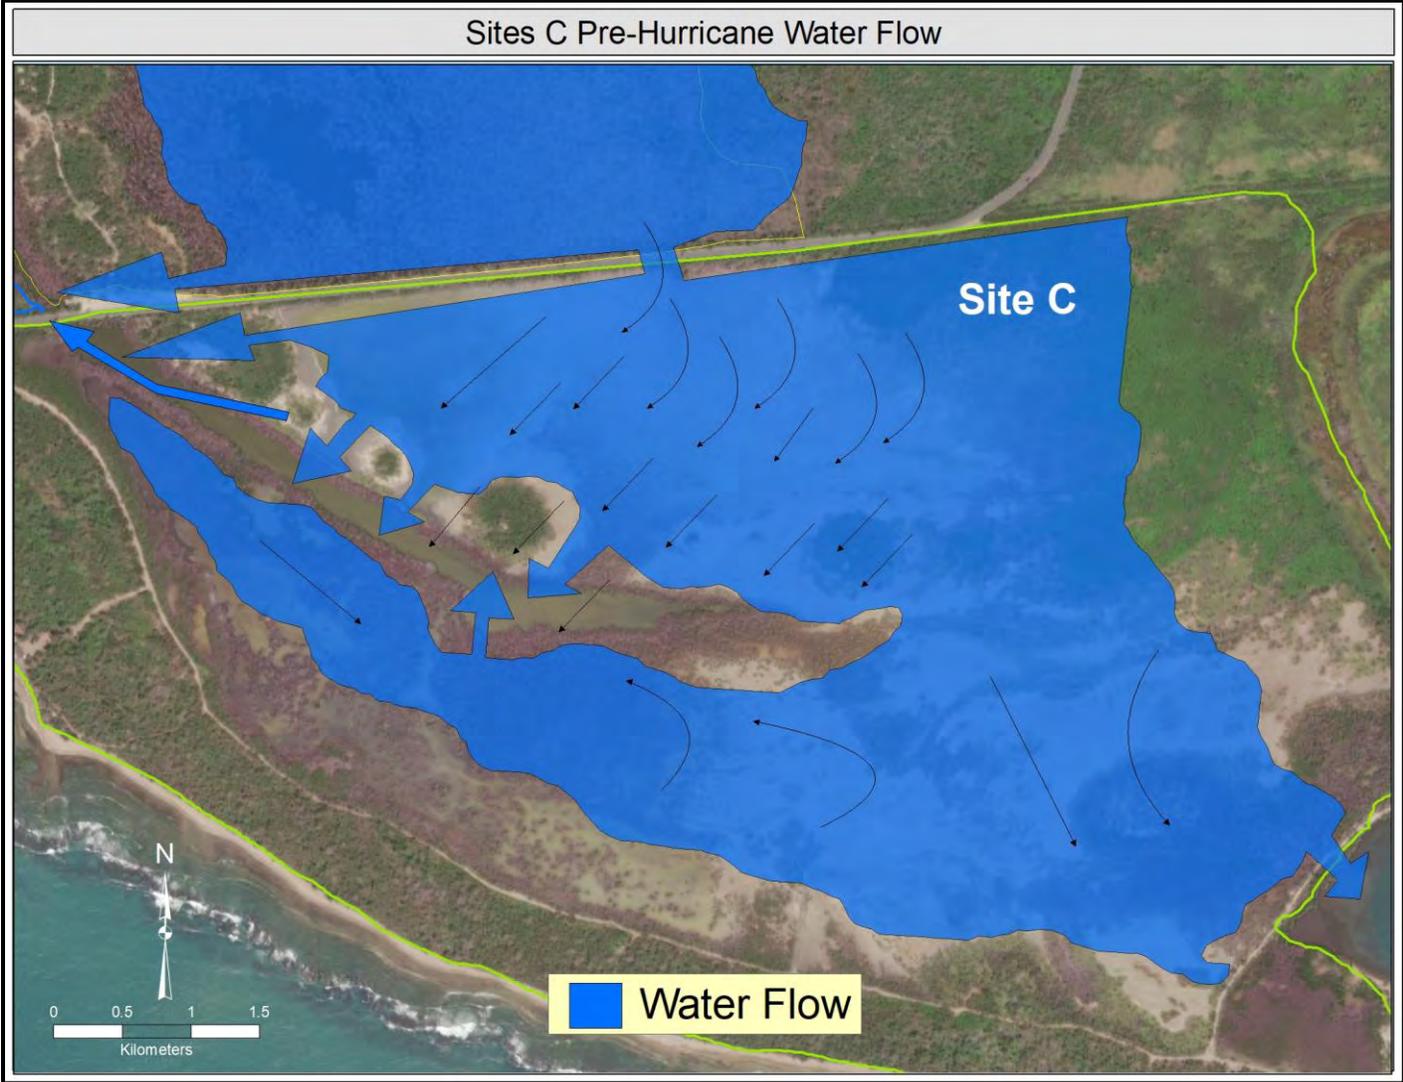
Figure 3C. Site C general water flow.

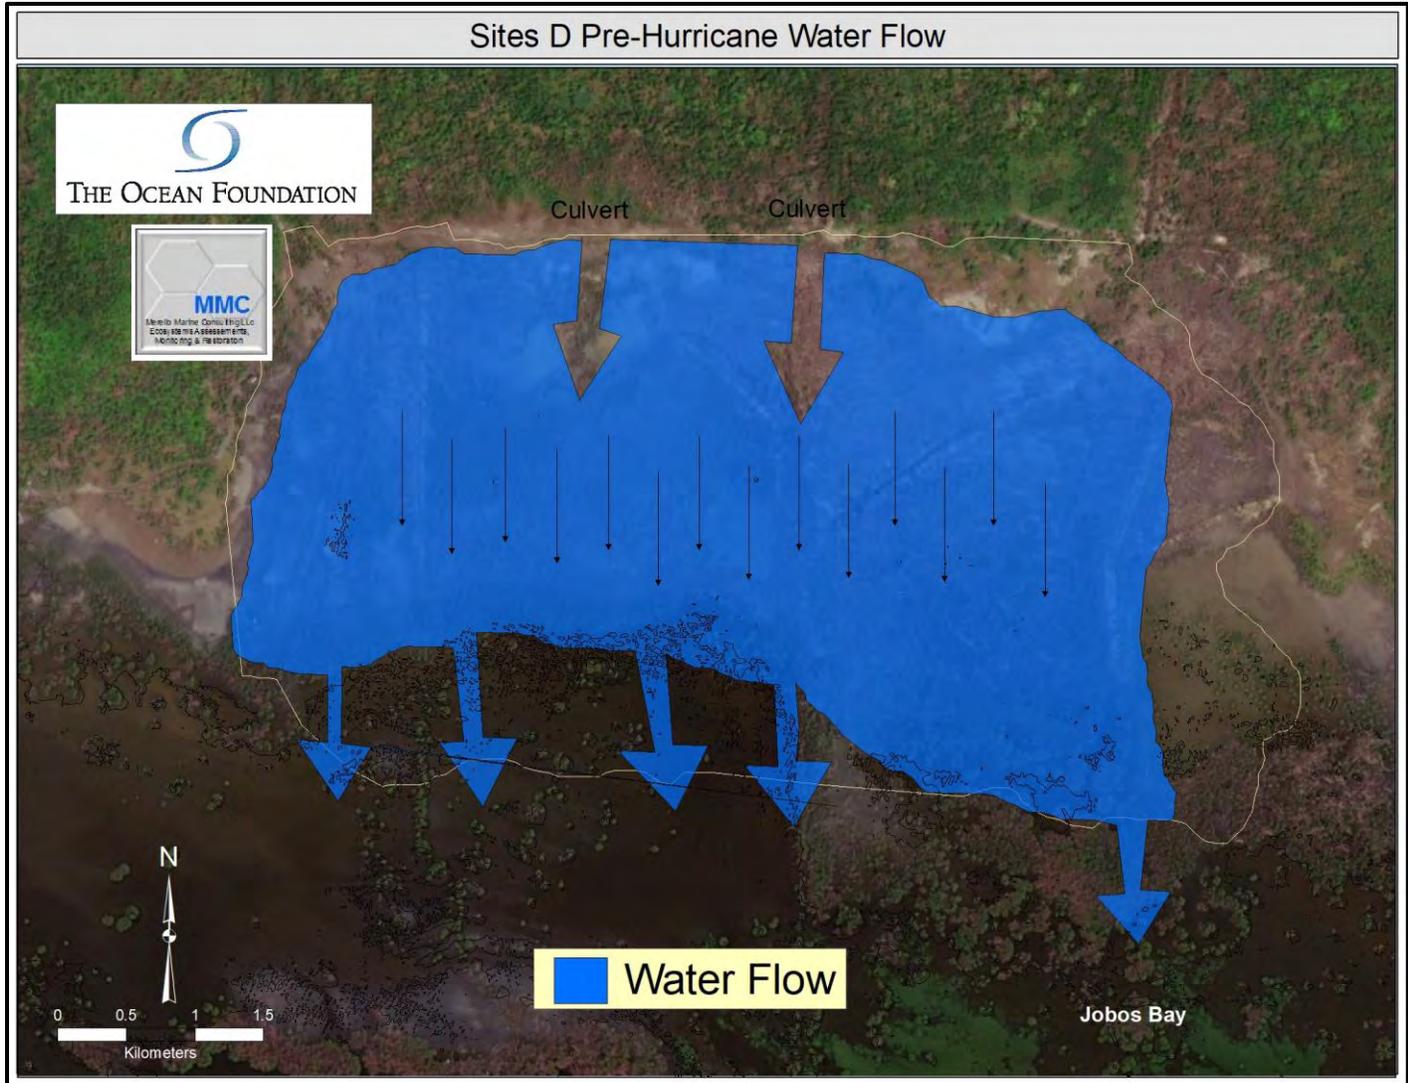
Figure 3D. Site D water flow.

Site D has two culverts that are no longer working to the North that drained water from u higher elevations, particularly precipitation into the system. The topographic relief has a natural gradient from land to the seashore that provides a natural and functional relative elevation for tidal flow and exchange. However, surface water flow is completely restricted in some areas due to accumulation of debris and fallen trees caused by the hurricanes (**Figure 3D**).
