## Natural Infrastructure Restoration to Enhance Climate Resilience in Puerto Rico

**“Assessing Jobos Bay and Aguirre Park (Puerto Rico) mangrove wetlands extension, shoreline condition and rehabilitation/restoration feasibility after Hurricanes Maria and Irma impacts (2017)”**

**DRNA/ JBNERR**  
In collaboration with  
**The Ocean Foundation**  
**Merello Marine Consulting**

**September 16, 2020**

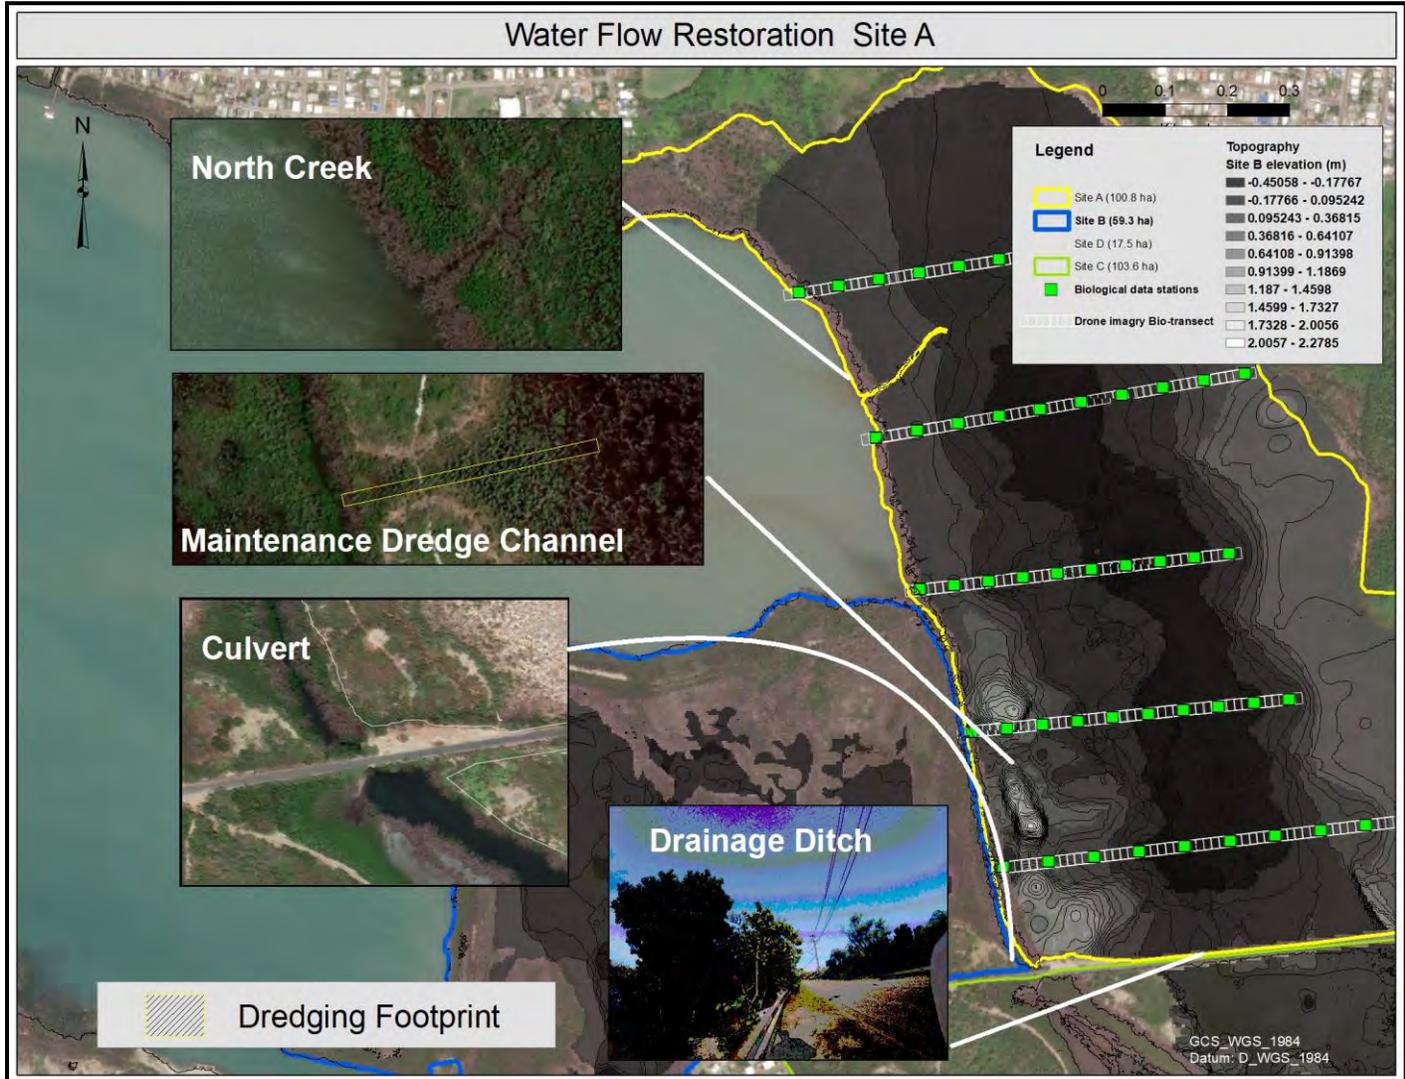
Figure 4A. Site A restoration area showing water flow restoration activities.

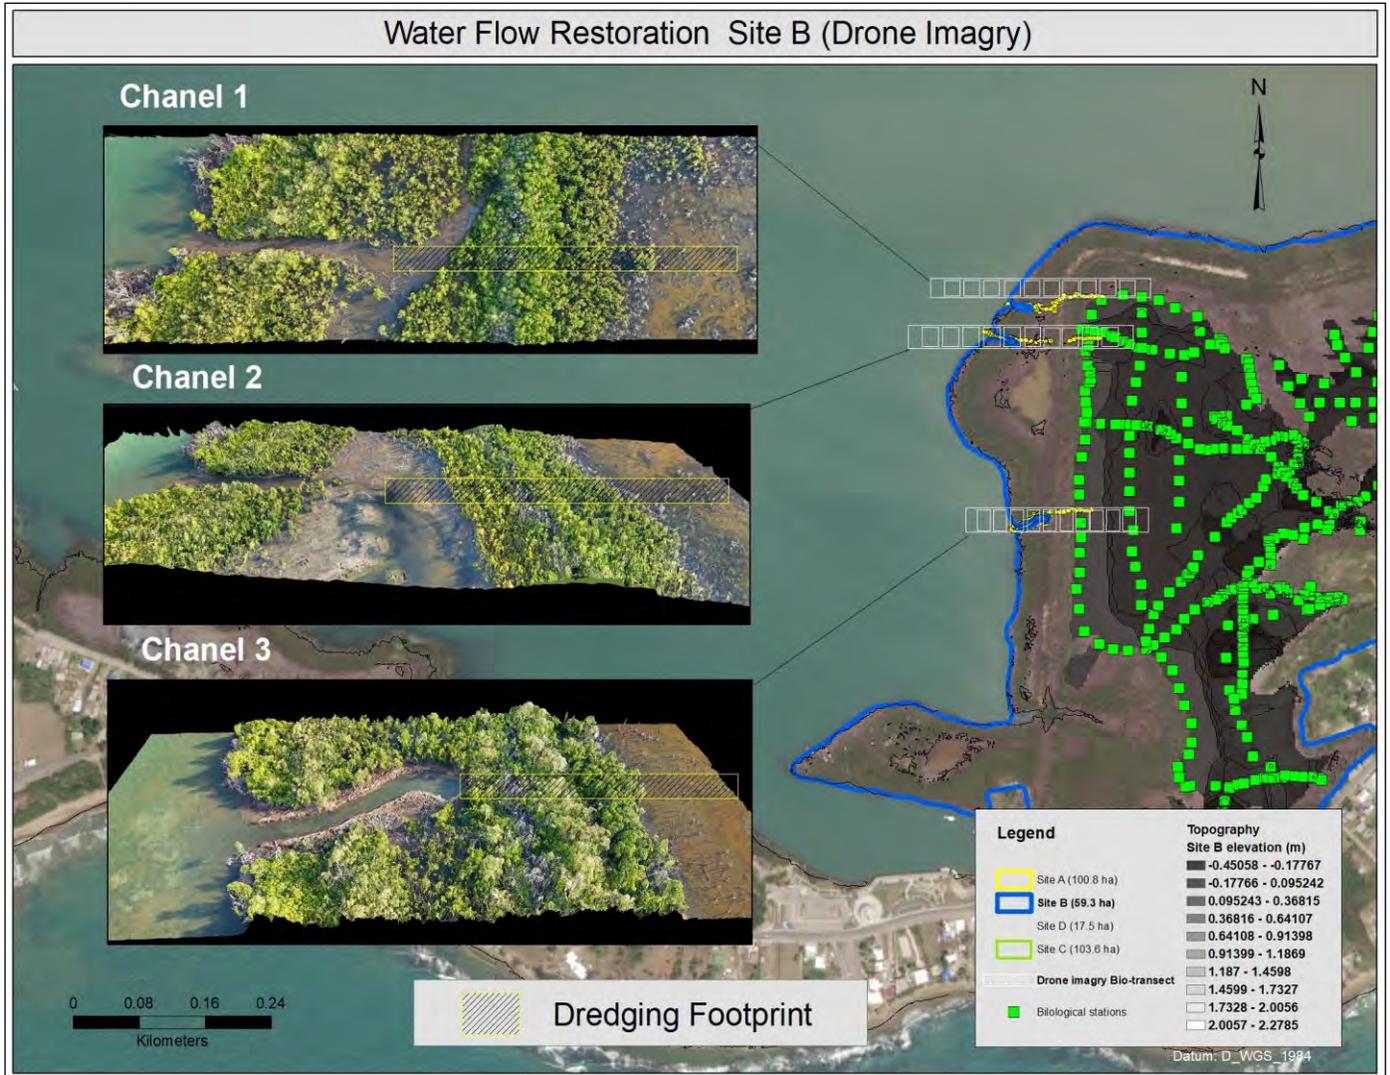
Figure 4B. Site B restoration area showing preexisting channel and proposed extension.

**Site B.** During vessel salvage operations, post Hurricane Irma and Marias' impact, three major channels were partially opened to extract several vessels that had washed up on top of the mangrove forest canopy. We propose to take advantage of these channels and extend them towards the damaged areas to promote water flow and enhance tidal exchange and water flow. A floating excavator can dredge an area of approximately 70 meters long by 2m wide and up to a meter deep; this is approximately 140 m<sup>3</sup> of dredge material along channel 1 and 2. In the case of channel 3 this rehabilitation action requires a dredged area of approximately 90 meters long by 2m wide up to a meter deep (180 m<sup>3</sup> ; **Figure 4B**).

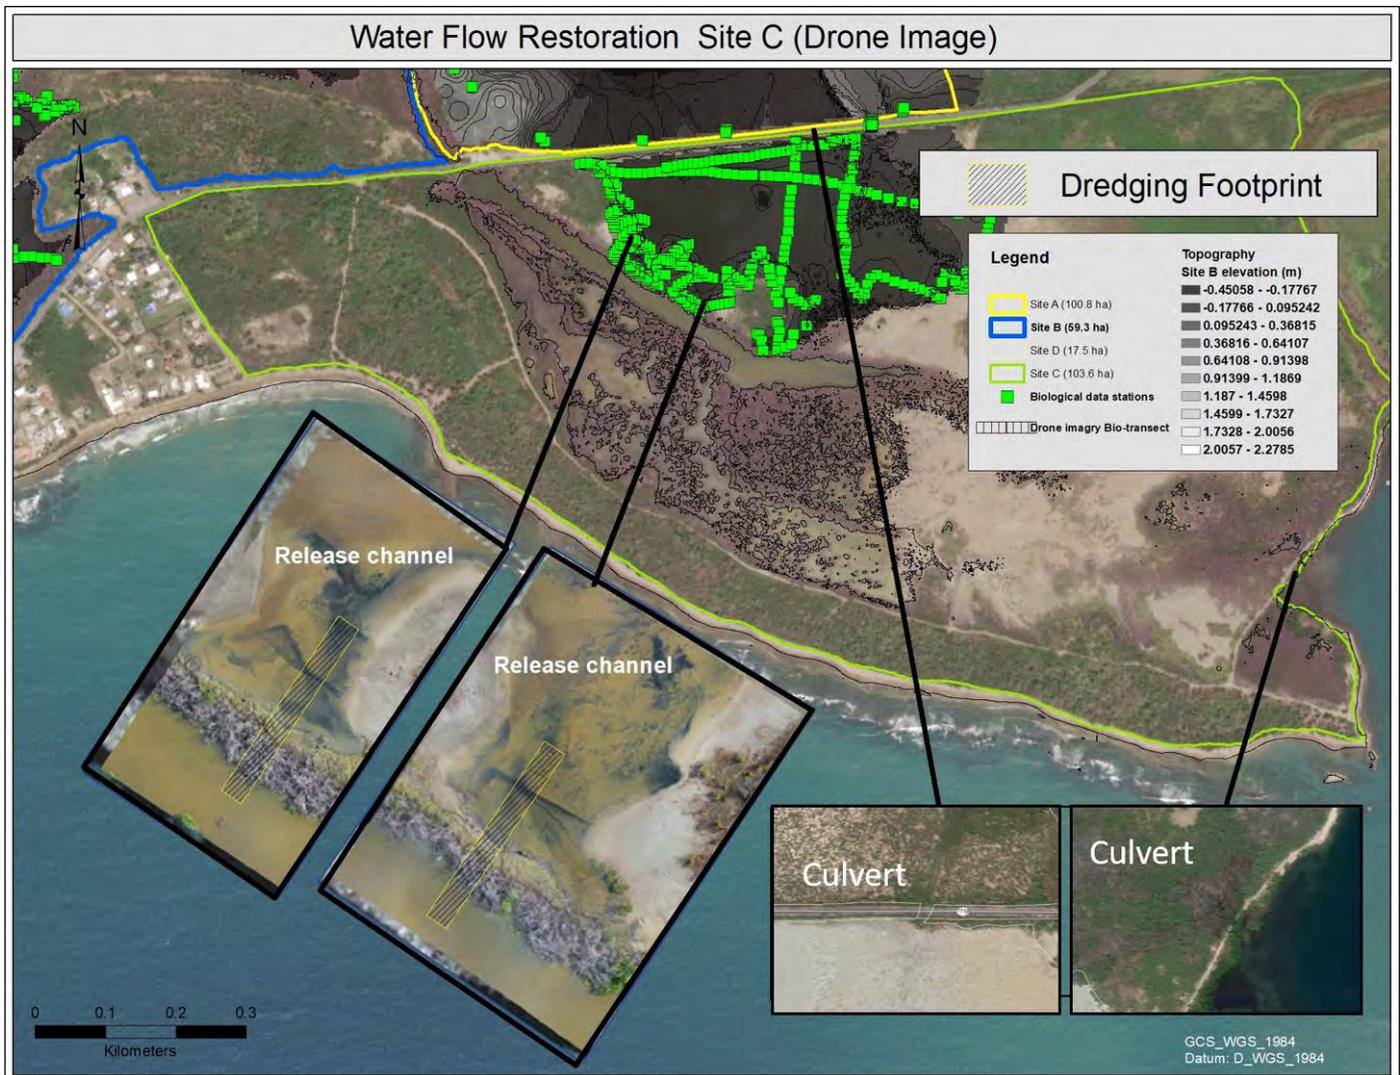
Figure 4C. Site C restoration area showing pre-existing release channel restoration.

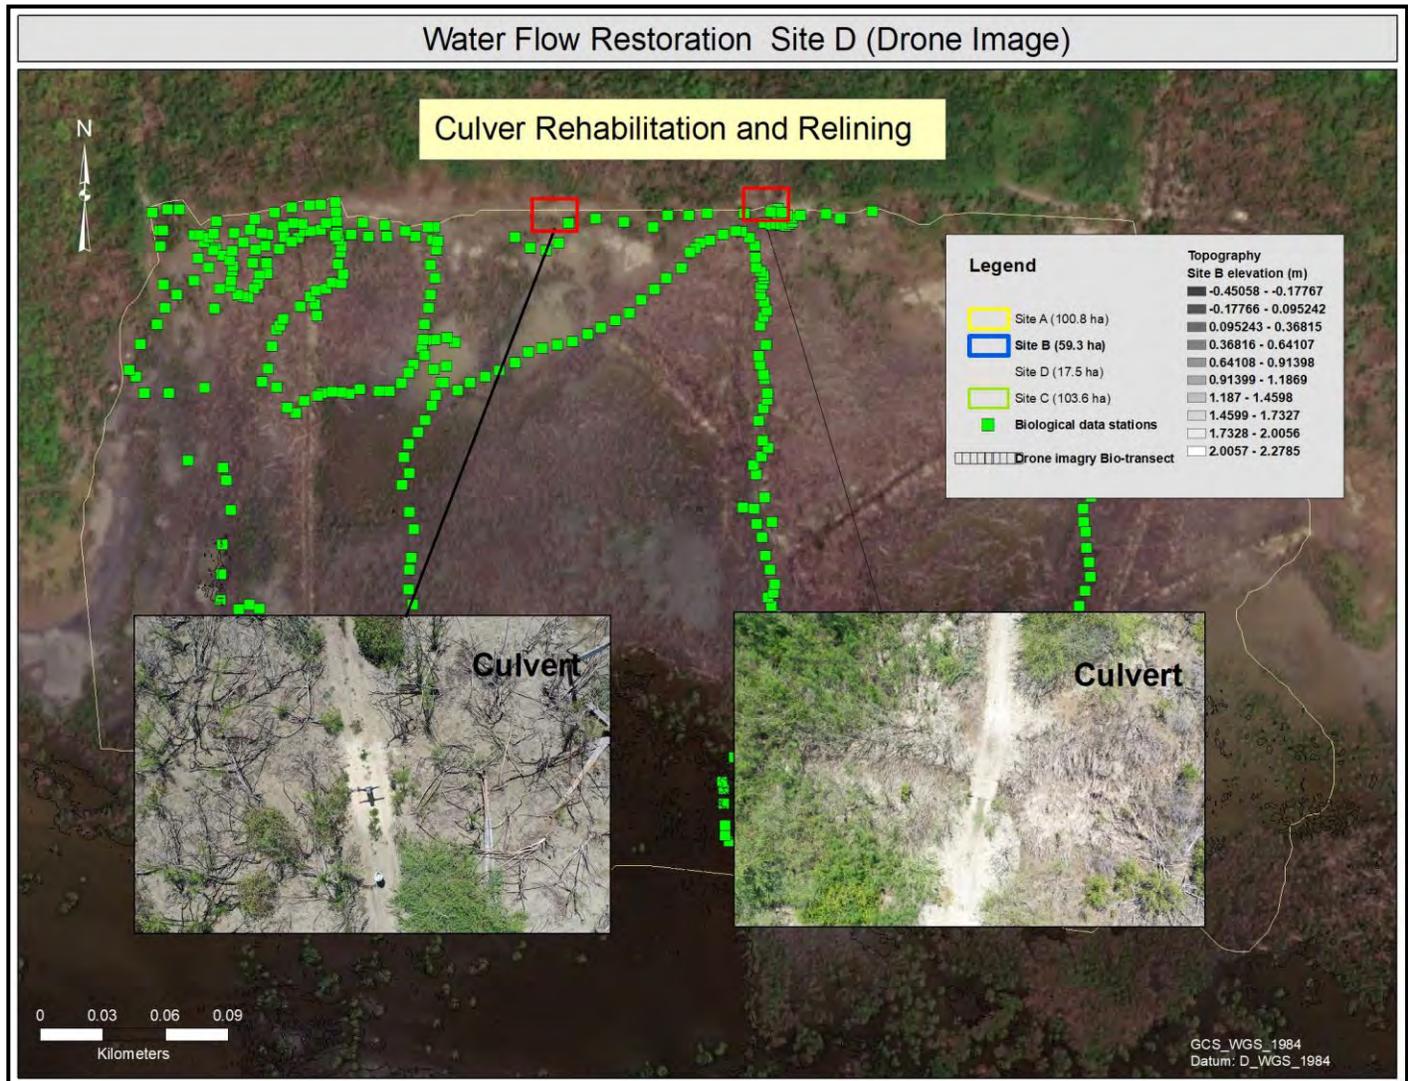
Figure 4D. Site D restoration area showing habitation and relining of s culvert locations.

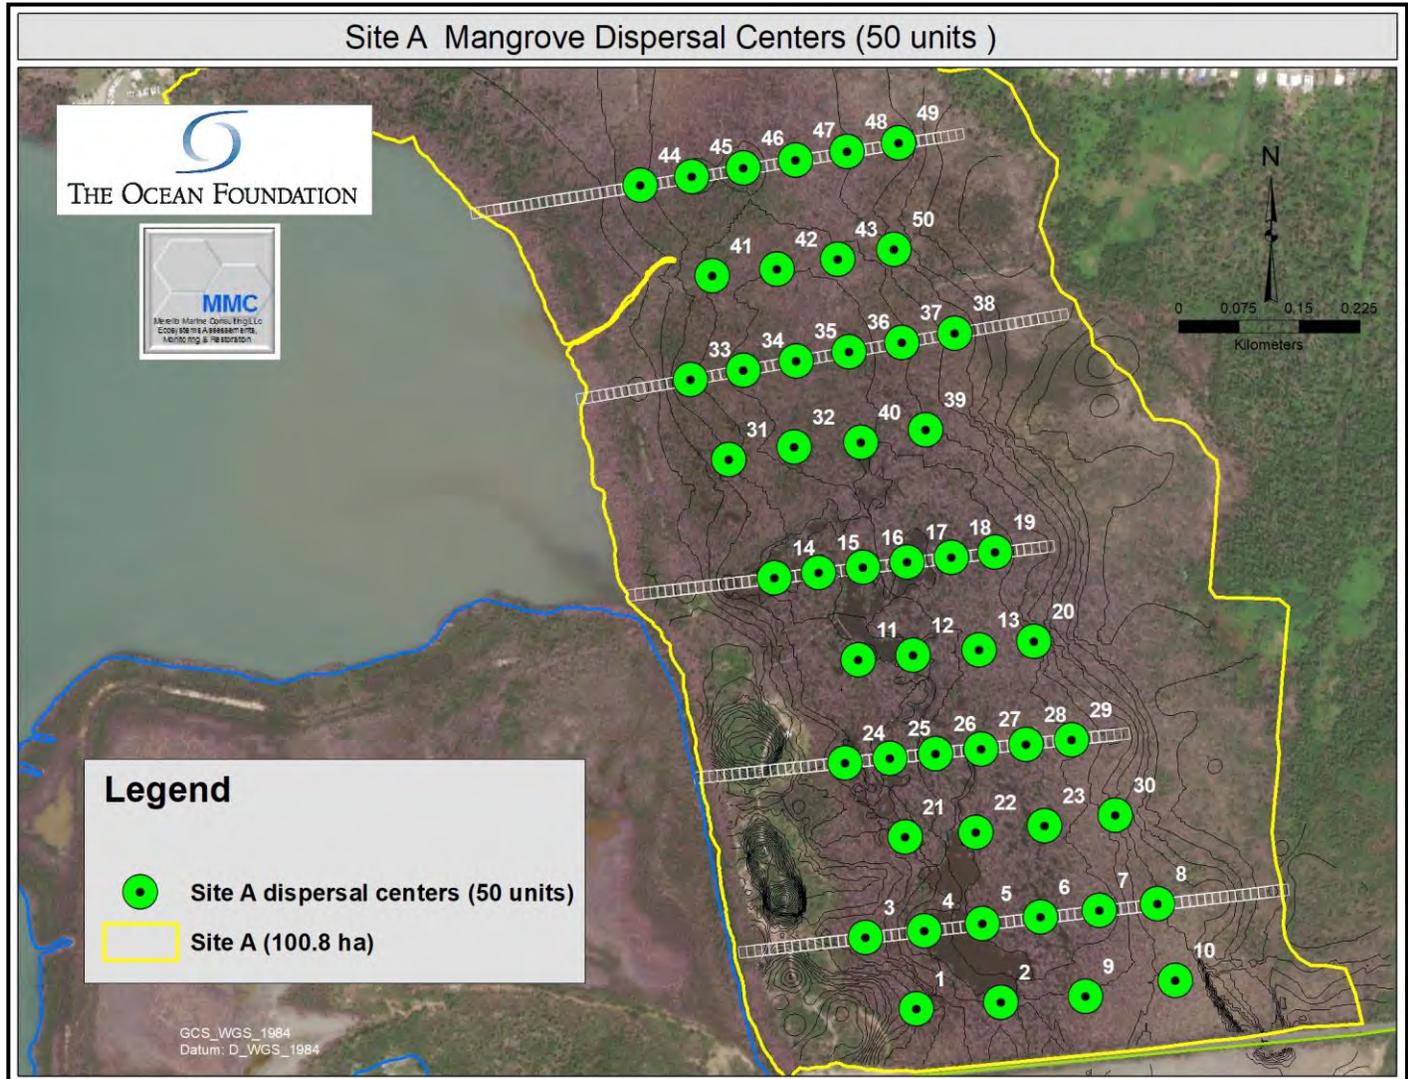
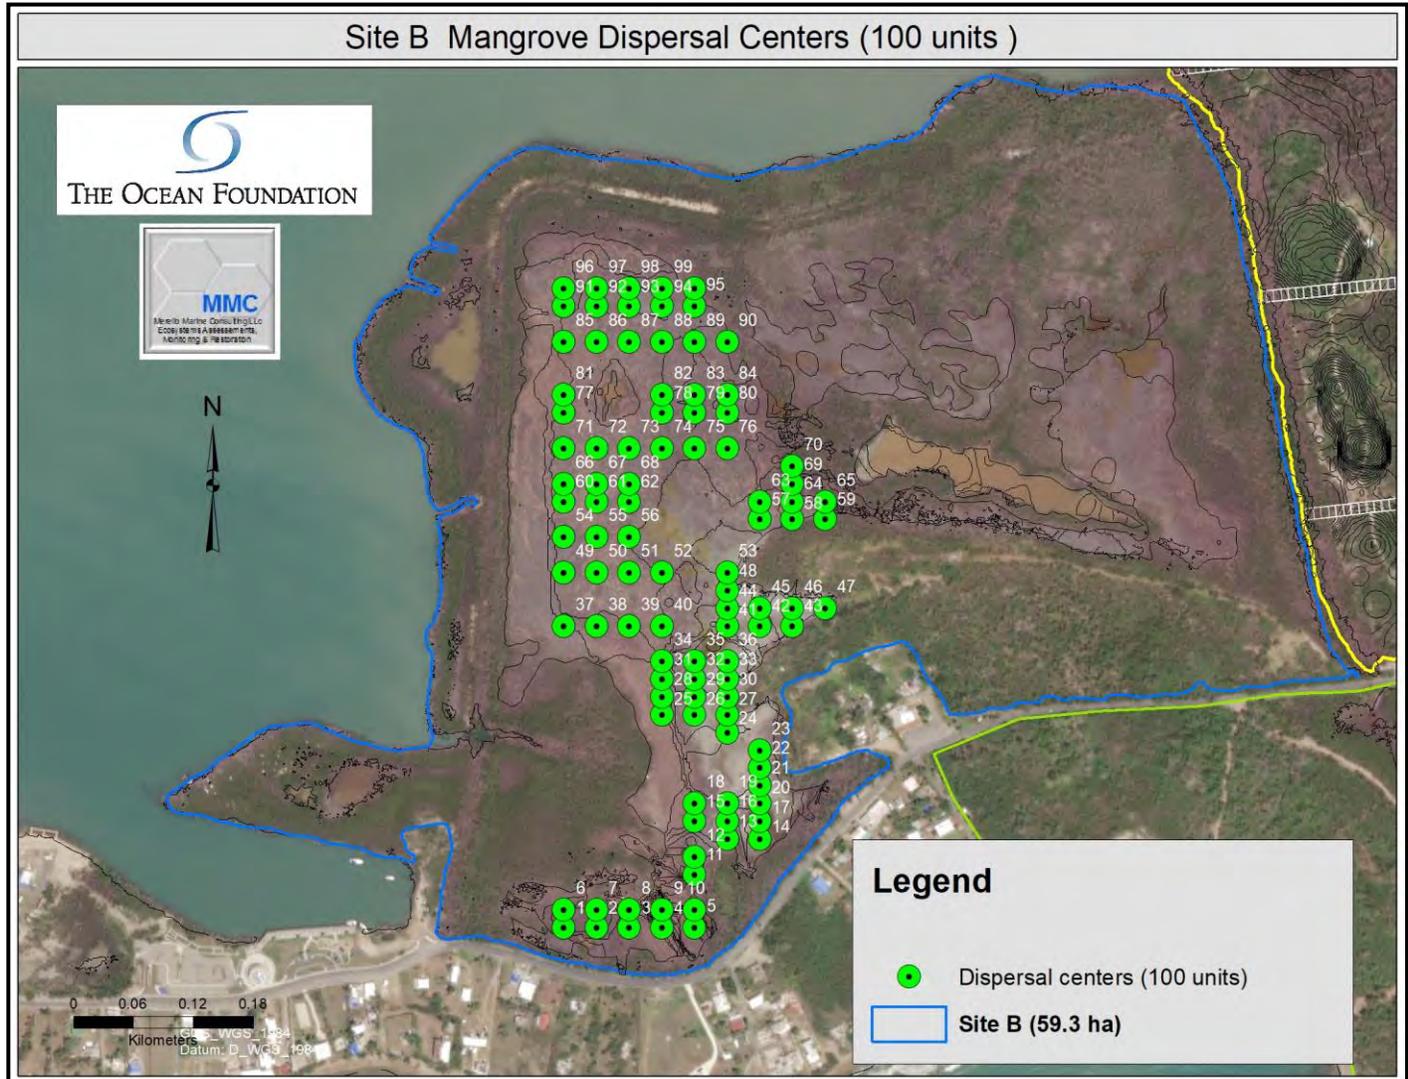
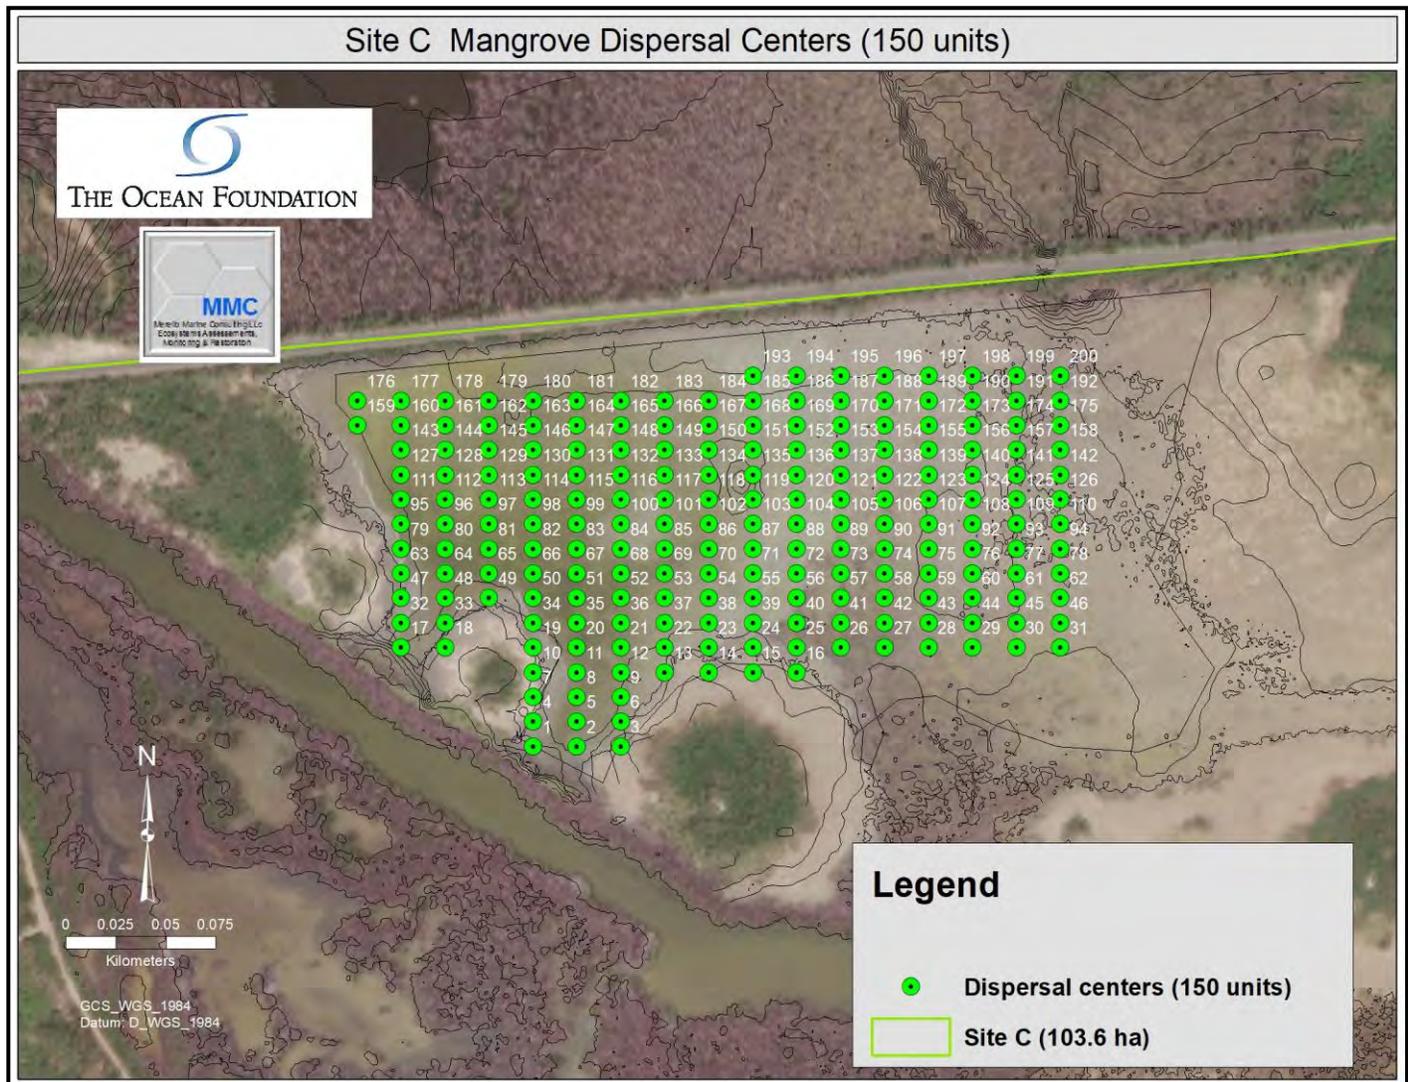
Figure 5A. Site A restoration area showing mangrove SAFE SITES

Figure 5B. Site B restoration area showing mangrove SAFE-SITES.

Figure 5C. Site C restoration area showing mangrove SAFE-SITES

Mangrove seedlings and saplings will be collected from four pre-selected donor sites by manual harvest, coring plants using a combination of direct removal via hand, shovel or using an iron corer with a diameter of about 10-15 cm depending on the age class (i.e., combination of diameter and height) of the selected individuals. The corer is inserted into the ground for about 20cm to 25cm. Coring will be performed to minimize damage to the roots of the target seedlings to be collected. A total of 300 SAFE-Sites (i.e., cluster of plants that have the potential for maturity and seed production and propagule dispersal, see appendix A image 2) containing 5 – 10 seedlings and /or saplings will be transplanted at the restoration sites. The number of plants per dispersal centers will fluctuate depending on the plant size and species and site conditions (combination of hydroperiod, stressors, resources). At **Site A**, 50 SAFE-Sites will be installed containing approximately 500 plants. **Site B**, will host 100 dispersal SAFE-Sites for a total of approximately 1000 plants; while at **Site C**, 150 safe sites will be deployed (1500 plants). SAFE-Sites will be nestled within SAFE-Islands across optimal sites defined after the hydrological rehabilitation and hydroperiod. Given the current elevation gradient and hydrological connectivity observed in **Site D**, no SAFE-S/SAFE-I will be installed in this location. The spatial arrangement of the SAFE-S and SAFE-I within each location will be based on a repeated measurement random block experimental design (**Figures 5A, 5B, 5C**).

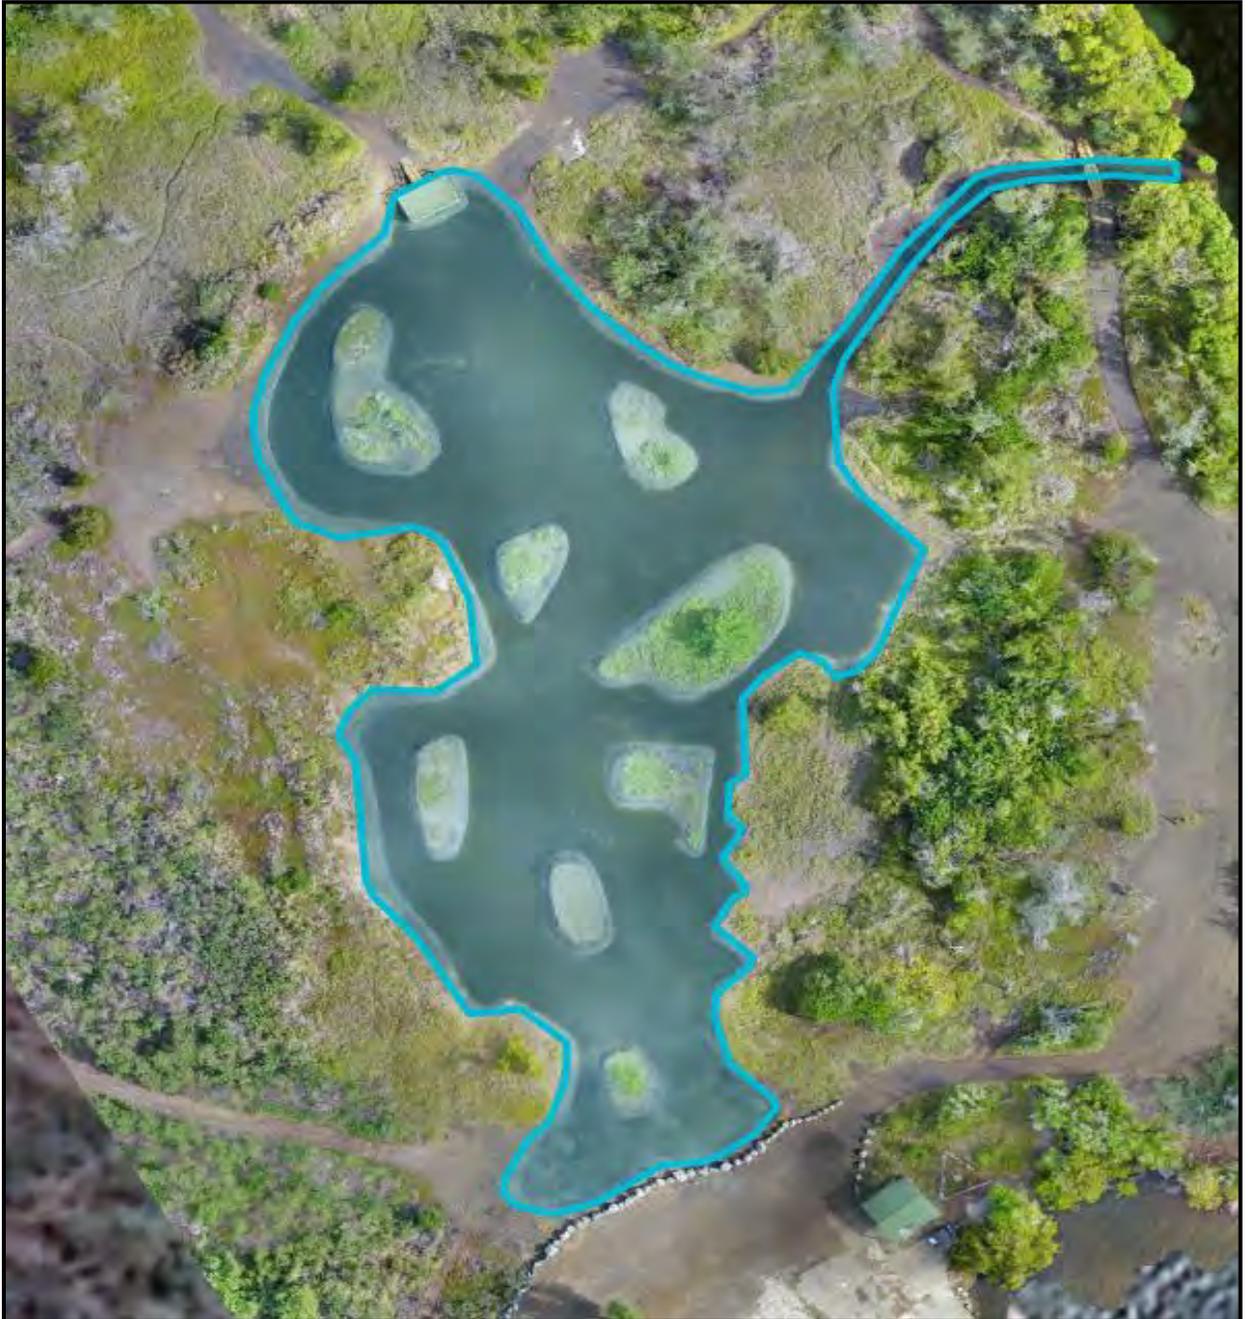
Image 1. Mangrove Nursery Site (Located within the property of JBNERR).

Additionally, we are proposing to establish a mangrove nursery area within the property of Jobos Bay National Estuary Research Reserve (JBNERR) to accommodate the restoration stock material. Plant stock material will be collected within a year prior to the restoration start date to allow time for the plants to adapt to in situ conditions and reproductive state to serve as viable units for the SAFE-Sites (See appendix A, image 2).
