Shippagan Gully Conservation Offsetting Project

Chiasson Office Spit

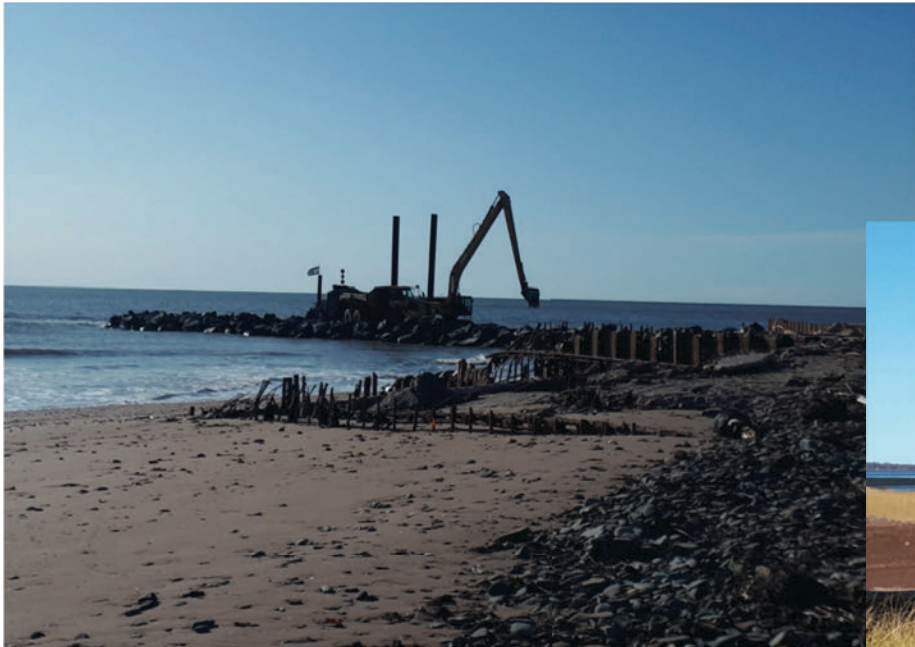
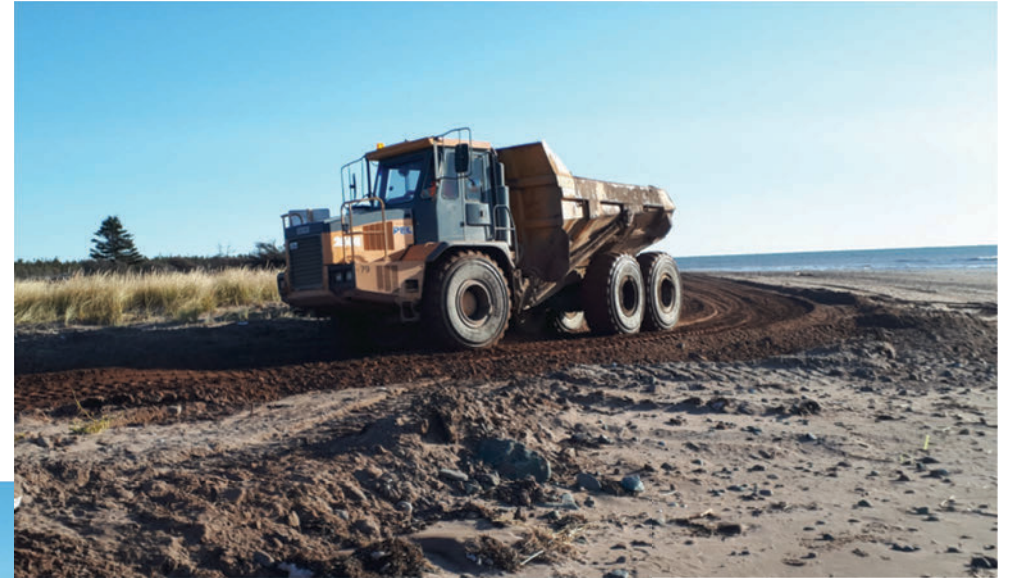
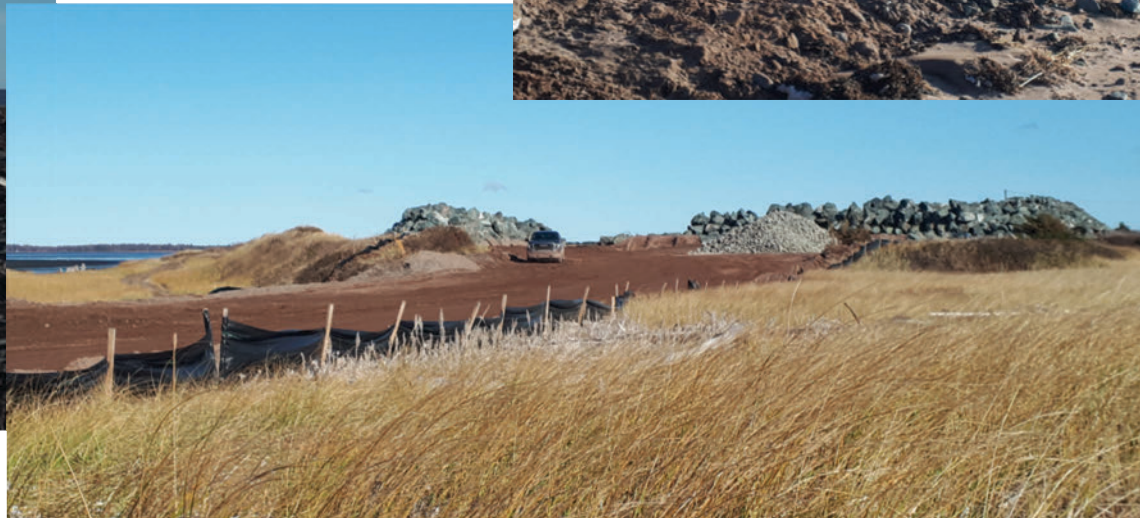
Sand Engine Construction 2020/21

- 200 m breakwater
- 158,817 m³ of dredge material at DS1

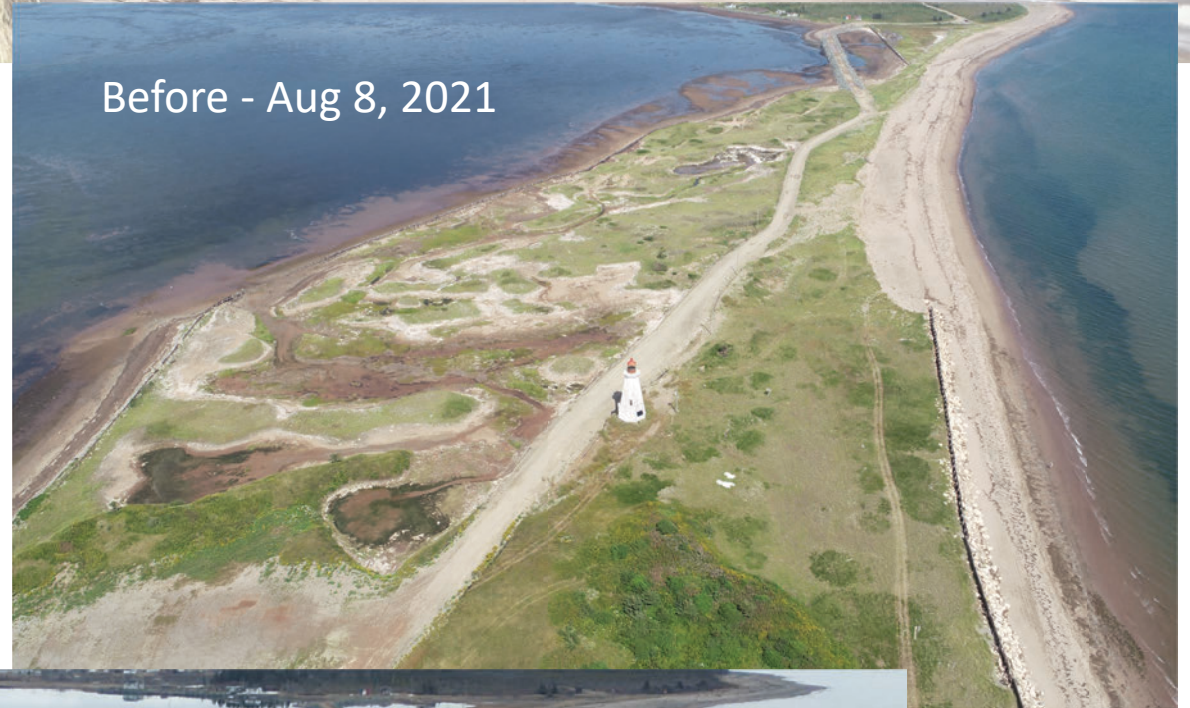
Before - Aug 8, 2021

- Seawall removal
- 1983 dredge reshaping
- Marsh construction

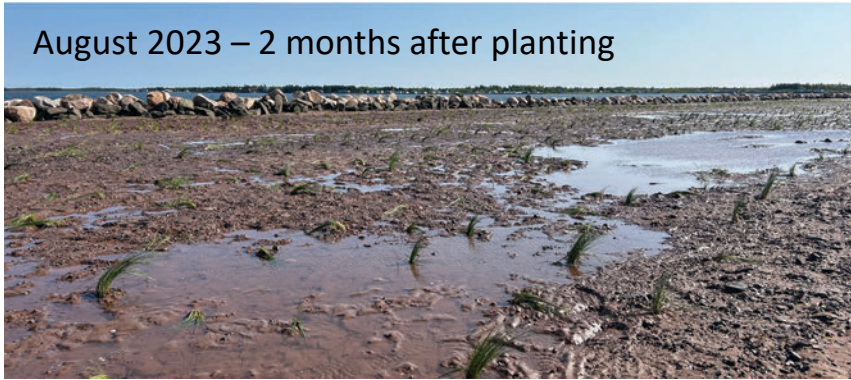
August 2023 – 2 months after planting

- Constructed marsh platform relatively stable
- Improved health in wetland 1
- New plants spreading in year 2
